Pukehiki Community Church 1868

The Restoration Story – A Photographic Record

PUKEHIKI COMMUNITY CHURCH – THE RESTORATION STORY (To November 2023)

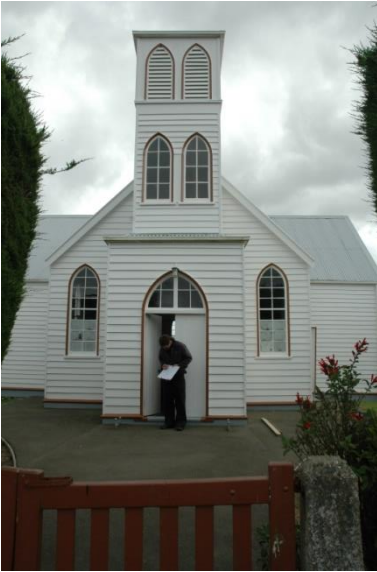
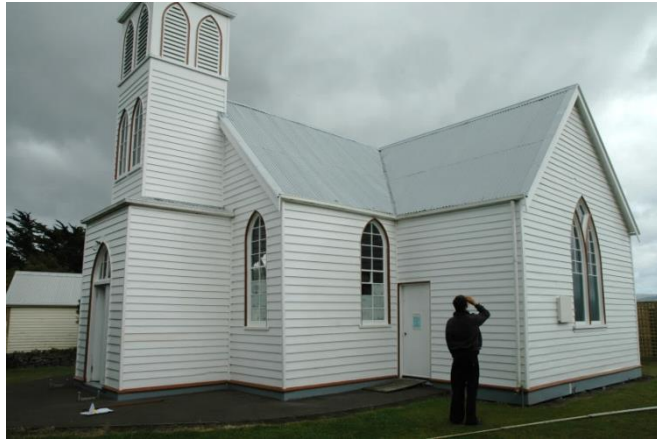
2007: The historic Pukehiki Church on Otago Peninsula looked to be in tidy condition, though the piles needed attention.

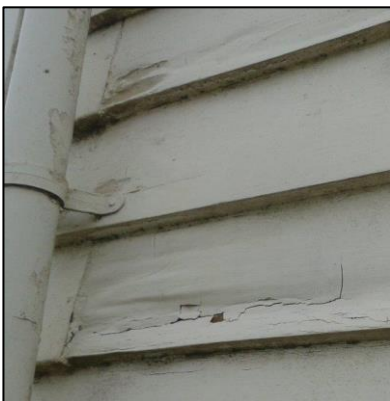
2014: After a 5 year break to repay loans for the repiling and drainage works, Stuart Robertson, a local joiner/builder was asked to repair a couple of weatherboards. **Which opened a can of worms!!**

2014/16: Alas everything was found to be in an overwhelming state of decay with a new disaster at every turn. Repairs to the south western part of the church were extensive, highlighting the major renovation task now faced by the Trust relating to the rest of the church structure

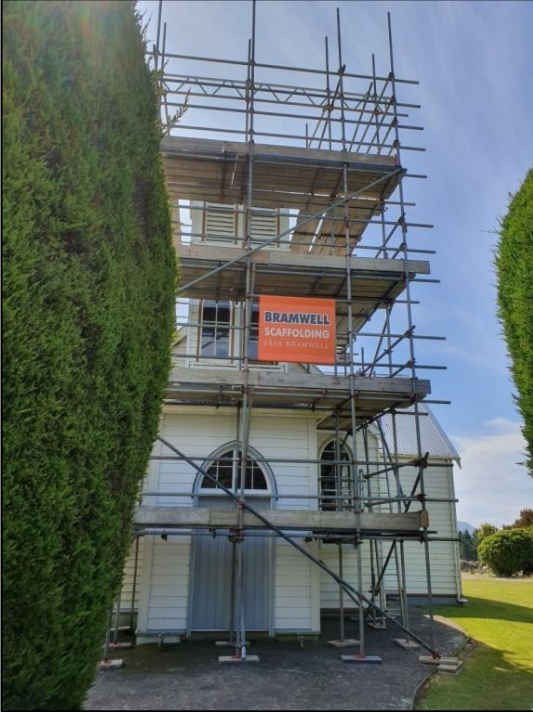
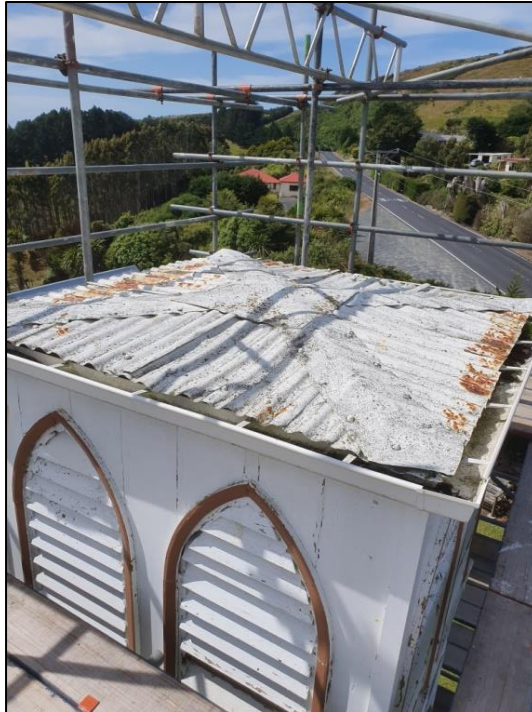
February 2020: With scaffolding erected the Bell Tower could be inspected. Again, deterioration and rotting timbers were found at every turn.

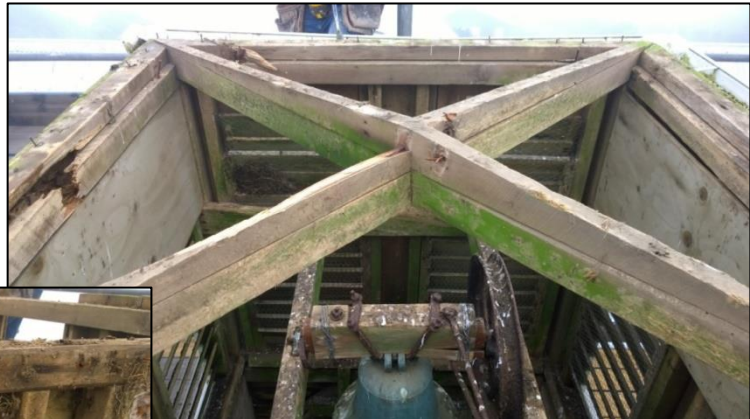
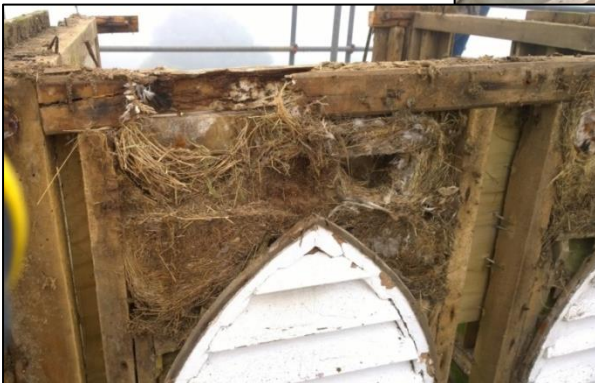
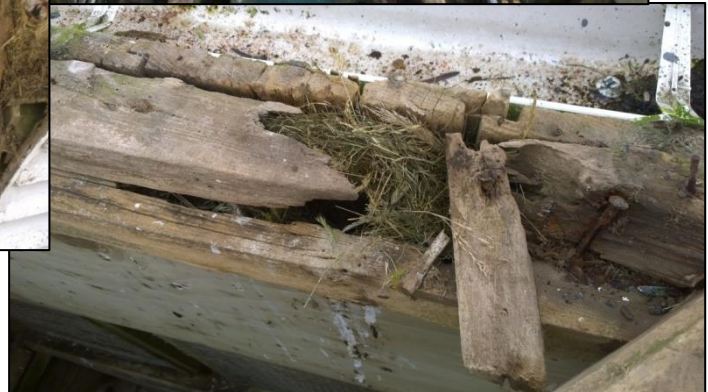
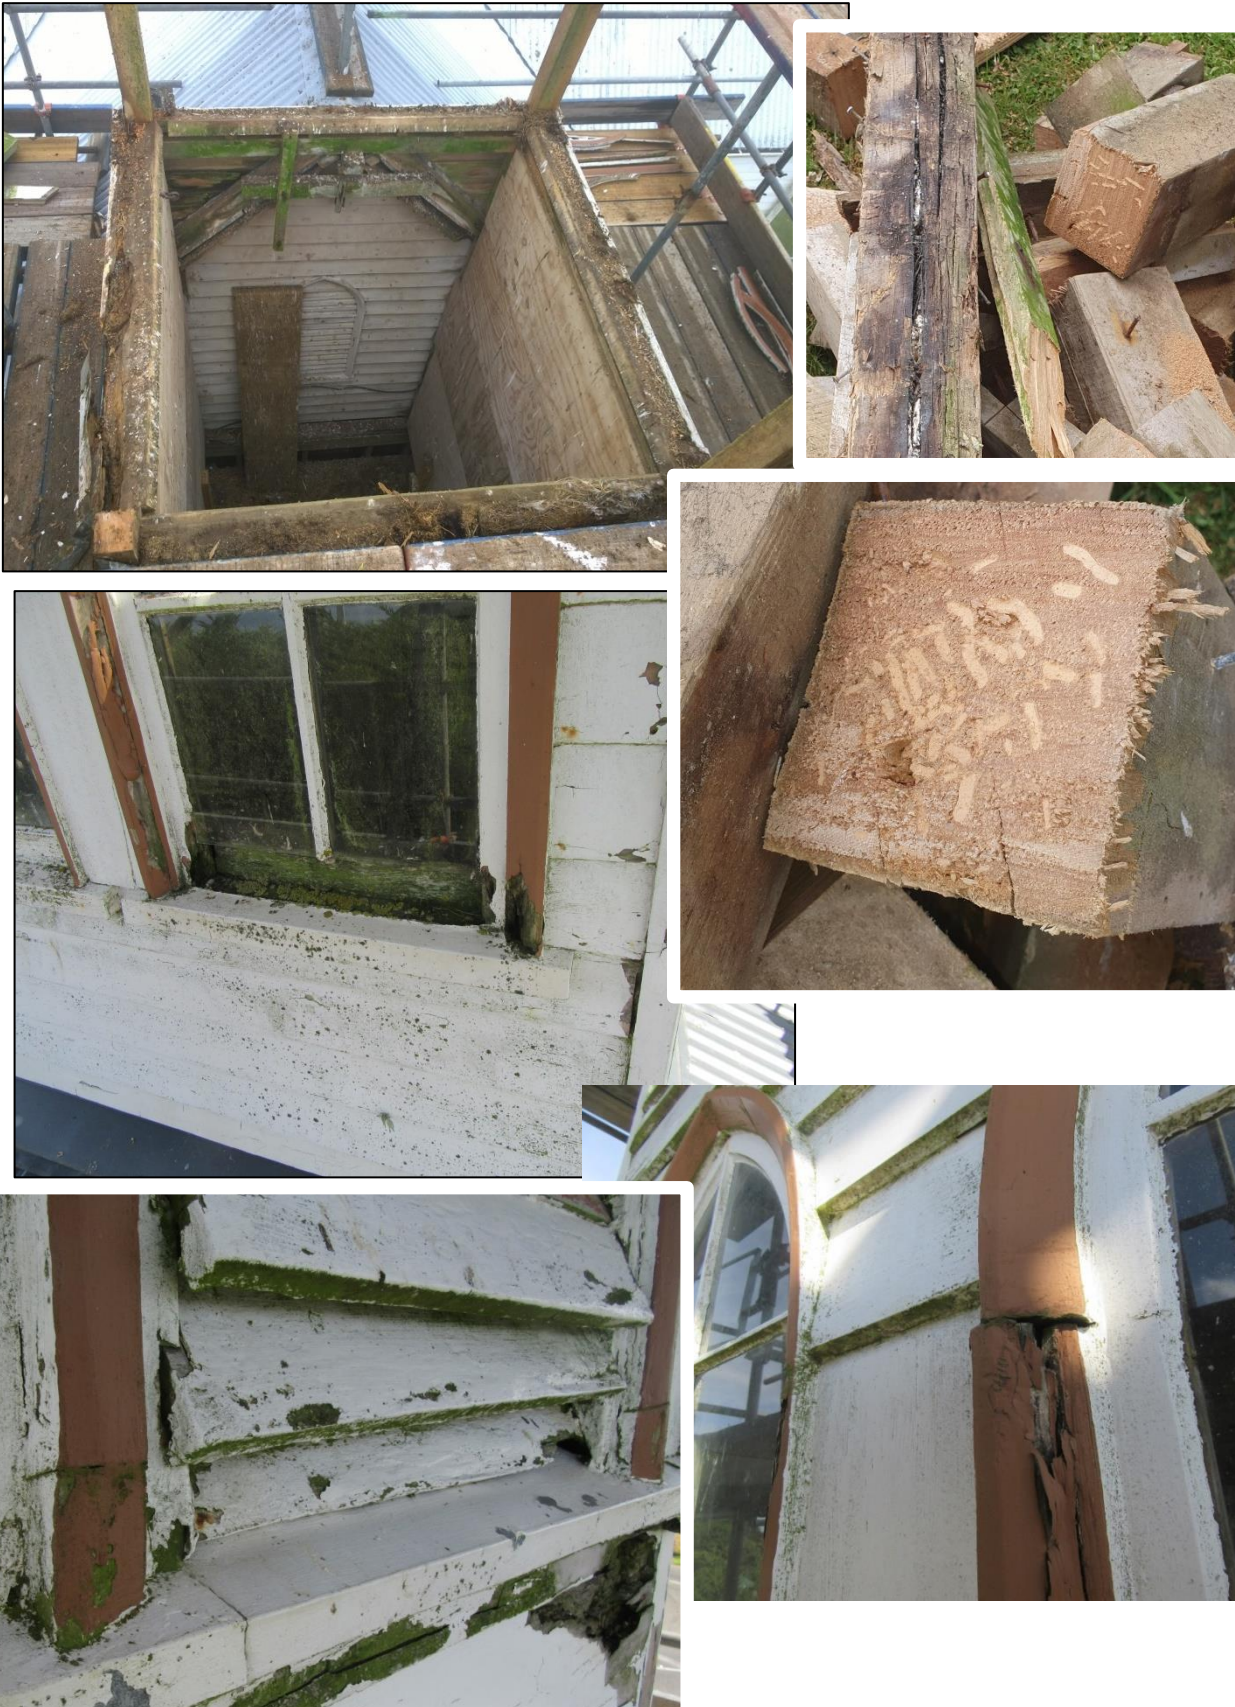
February 2020: The main support posts of the tower were badly riddled with borer and the windows and louvres badly decayed. The tower needed to be rebuilt.

March 2020: Starting again!

Tower reconstruction commenced, with temporary ply cladding placed for weatherproofing pending restoration of the eight timber louvres and two windows to the exact original details.

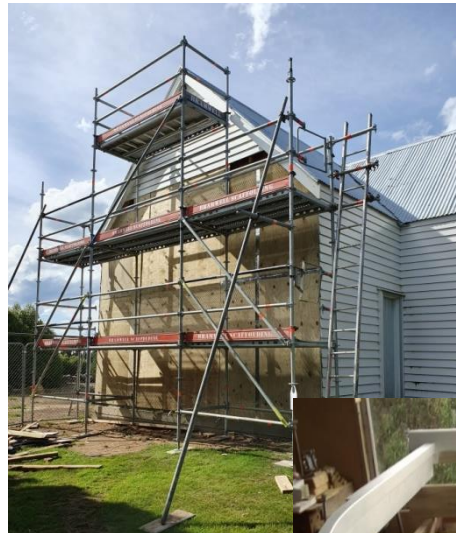
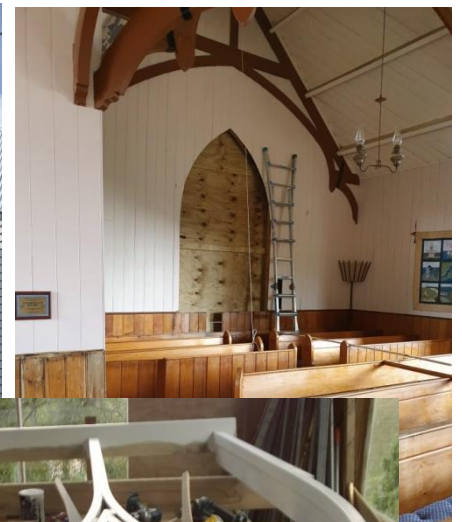
March 2020: Work progressed on to the south-west wall, with removal of the large window for repair

Stuart's fabrication of the new window frame looks impressive.

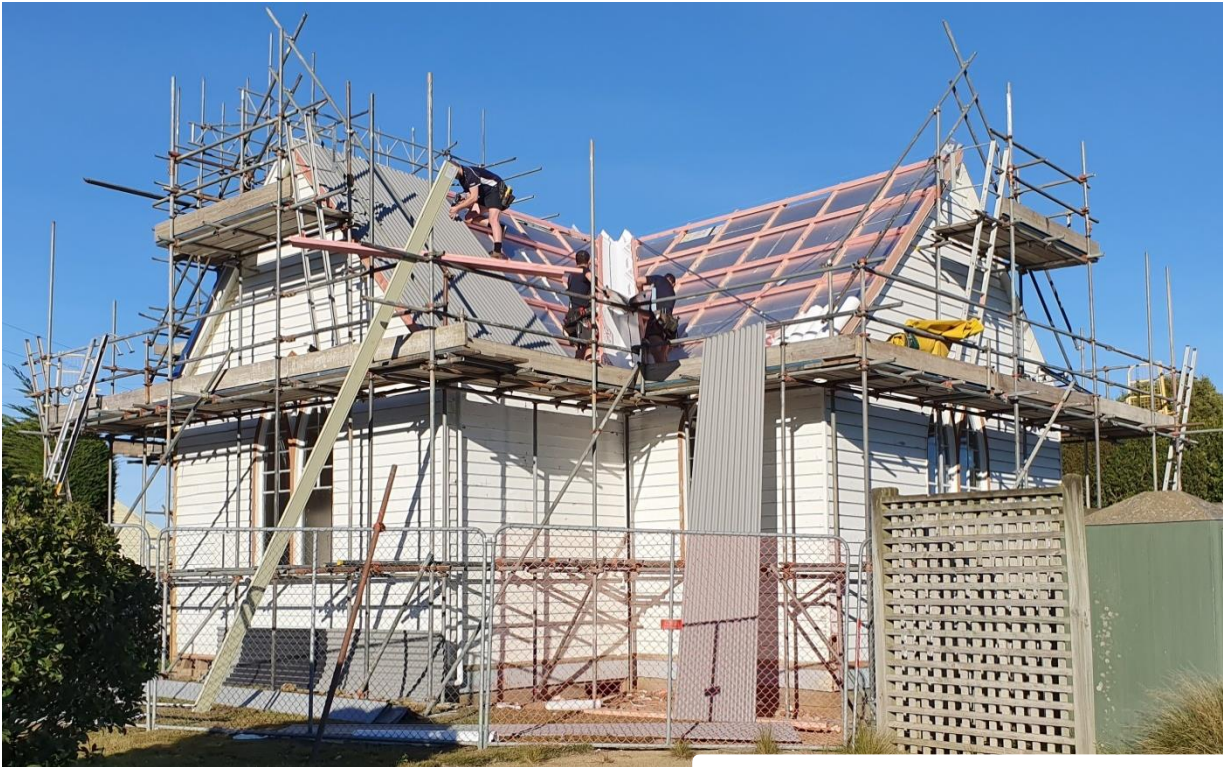
June 2020: After a nearly 2-month Covid-19 break, work finally resumed, with a start on the roof replacement (10th June 2020).

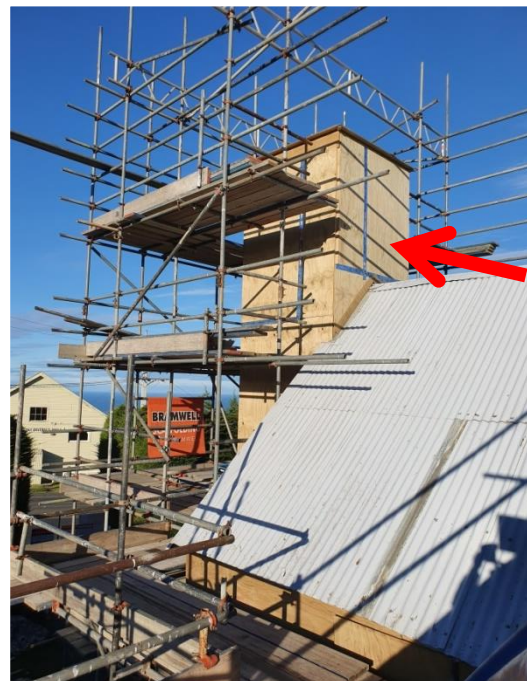
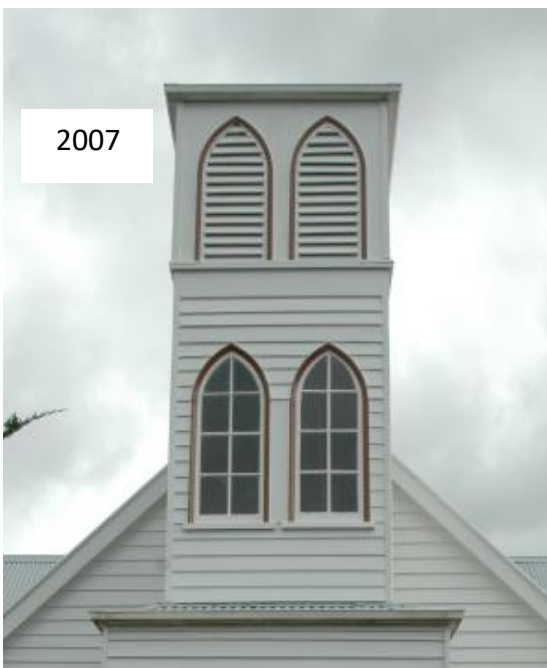
Completion of the tower is presently delayed pending restoration of the eight tower timber louvres and the two windows, along with other Stage 1 windows, all of which are being restored to the original tower detailing (as shown below):

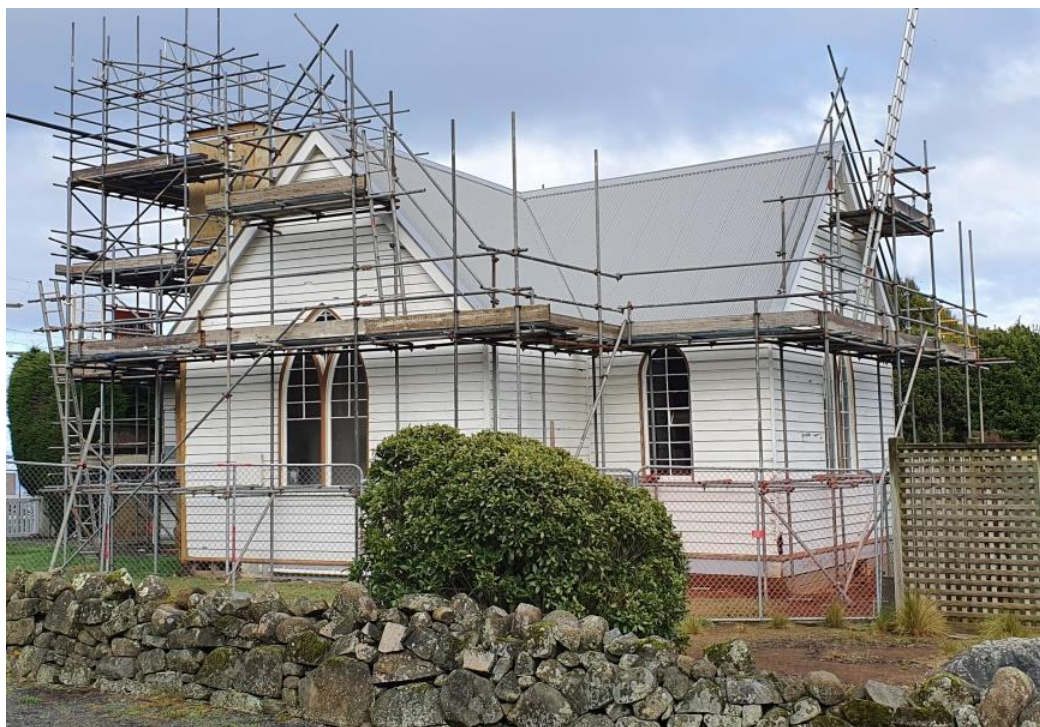
August 2020: By August, the new roofing and the painting of eaves, fascias and soffits was complete bar a few finishing details. The completion of work on the bell tower, walls and windows was pending restoration of the tower louvres and windows being carried out off-site.

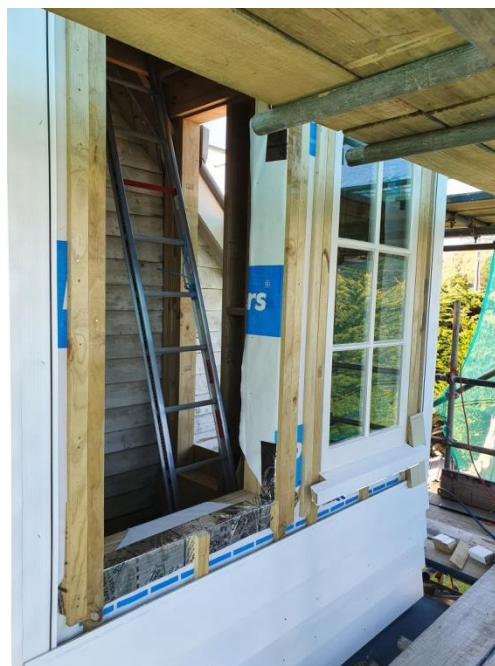
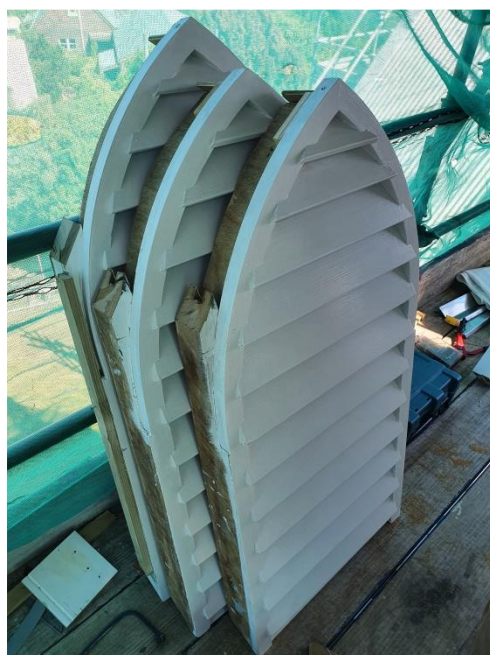
After 3-months's restoration in Stuart Robertson's workshop at Sandymount, (see "The Work of a Craftsman"), the restoration of the eight tower louvres, the two tower windows, the large southern window, and the four smaller Stage 1 windows was finally complete. Work commenced back on site, starting first with the installation of the tower windows (across).

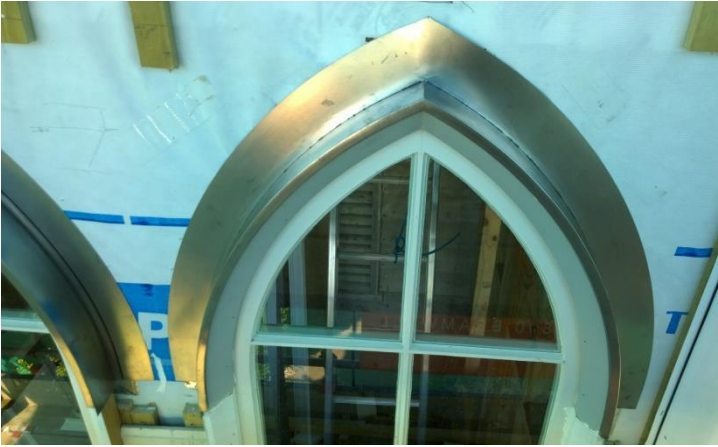
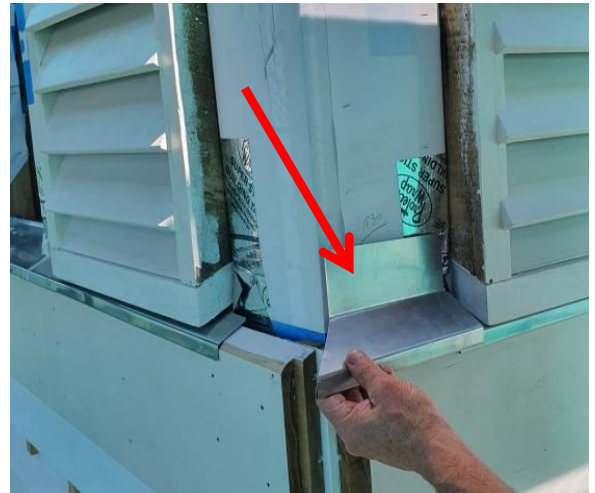
Work on the tower is progressing well, though recreating the original construction detailing by Walter Riddell 150 years ago is proving to be a very demanding and intricate process. While these details are being faithfully recreated, attention is being paid to long term weatherproofing, such as the fitting of fabricated stainless steel flashings over the windows and stainless steel sill flashings (arrowed).

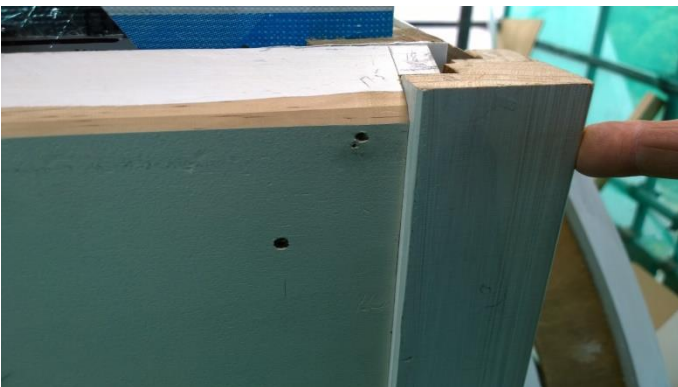
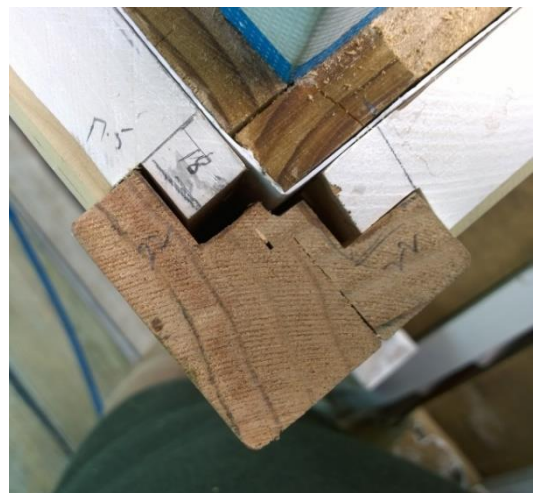
Reinstating the original square corner detailing has proven to be a challenging construction detail:

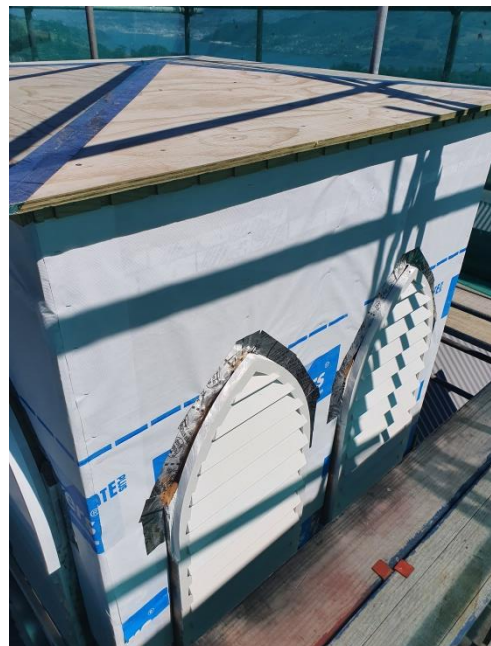
At the top of the tower, the restored louvres are being reinstalled

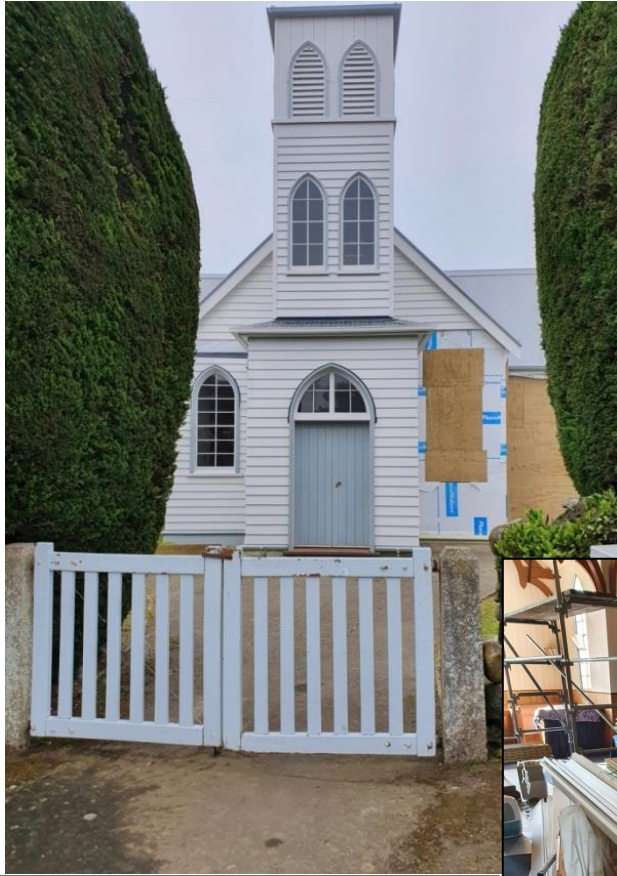
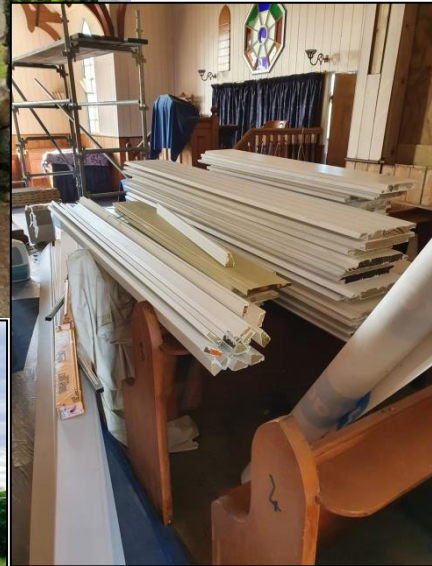
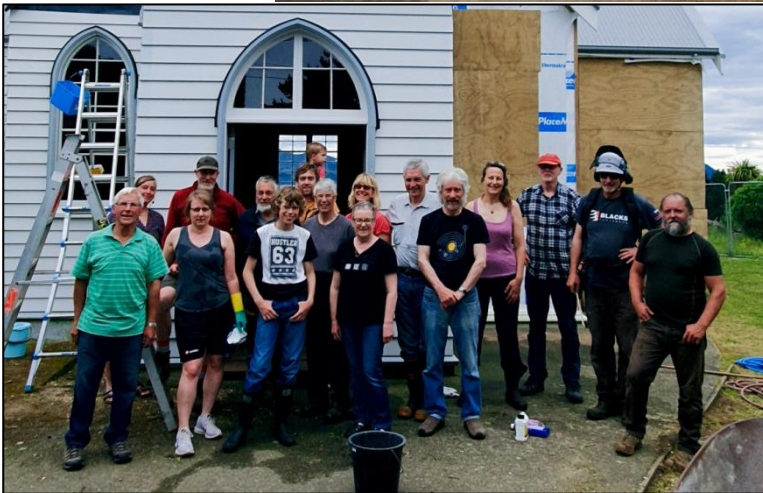
Finally! Just 3 days before the 2020 Carol Service, the tower scaffolding comes down to reveal the finished Bell Tower.

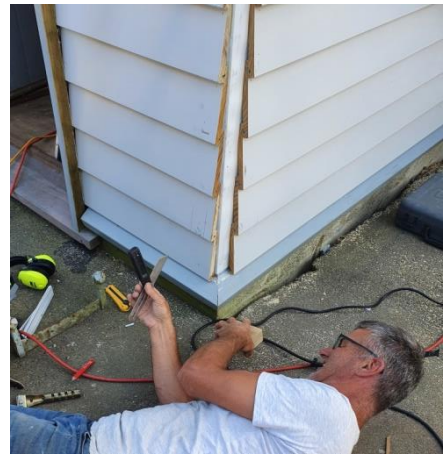
Graeme fitting and trimming the square corner detail

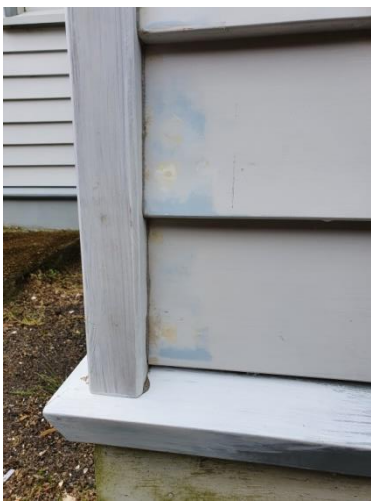
External square corner detail

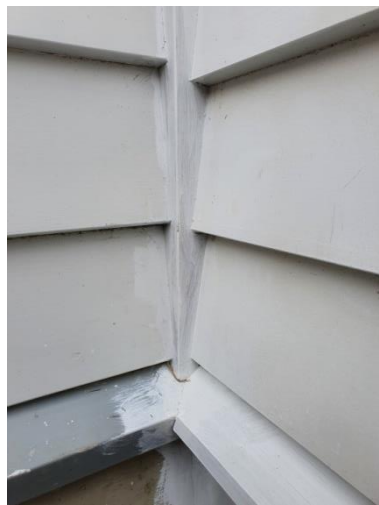
Internal square corner detail

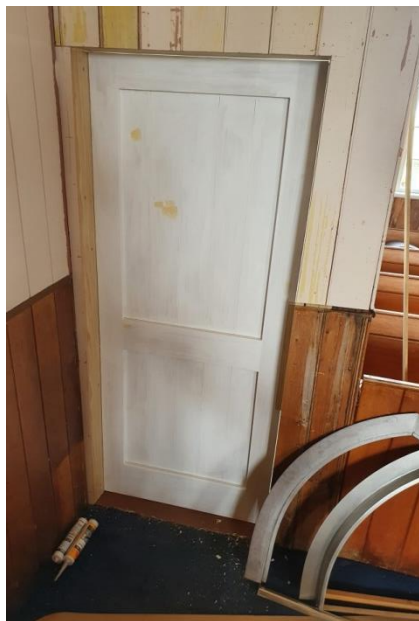
New side door installed

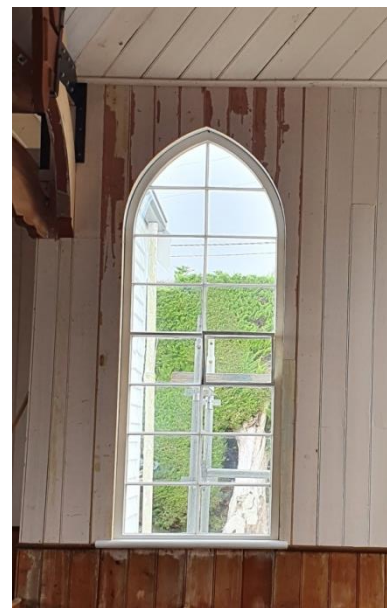
Interior lining around windows reinstated

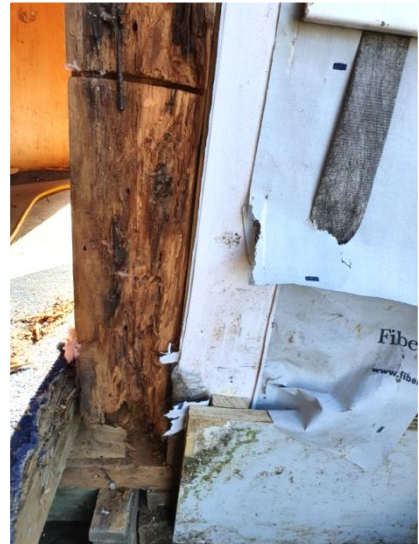
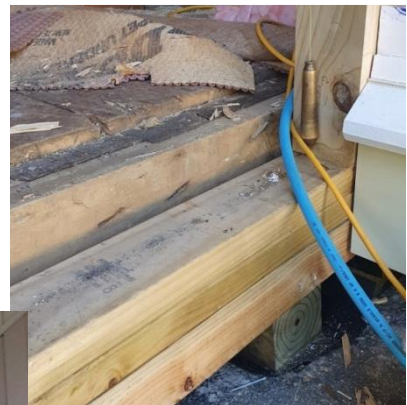
SE corner by the second side doorway – more rotten studs, (and a new corner pile needed).

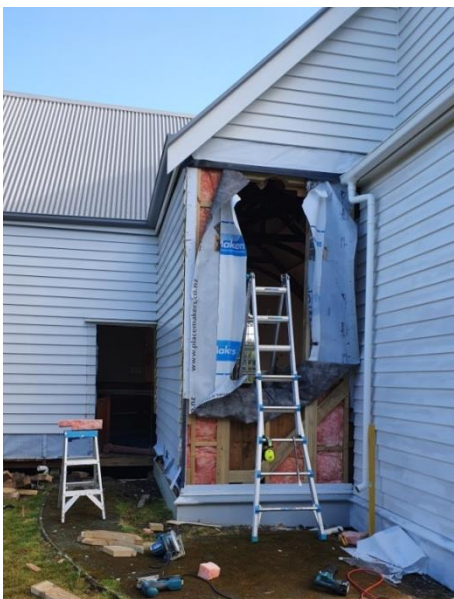
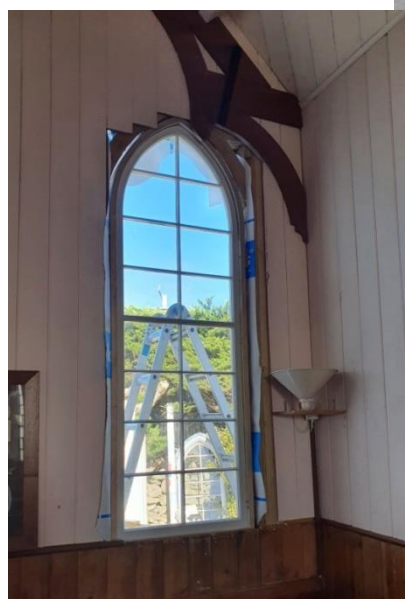
And a start is made on installing the new window on the left side of the bell tower

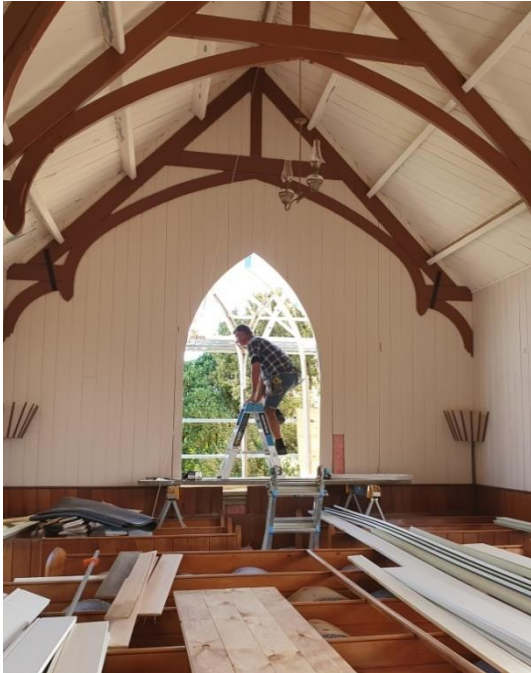
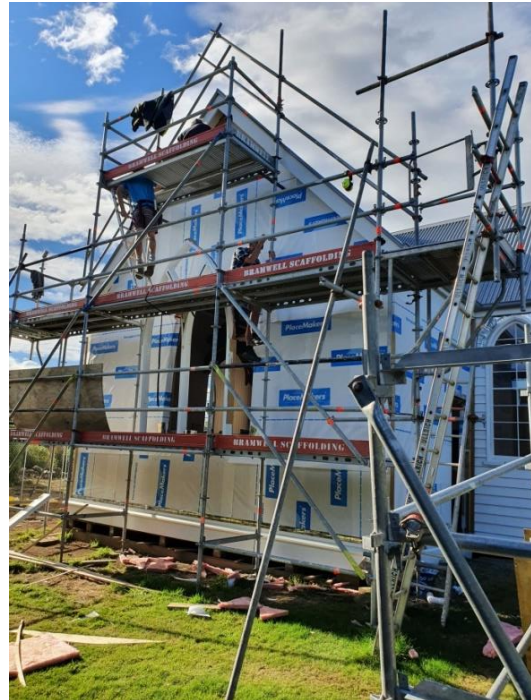
Great progress this month and the three builders, Stuart, Graeme and Tom, are hard at work. The new window to replace the one removed in 2015 is now in place and work is continuing on the end wall with the large window.

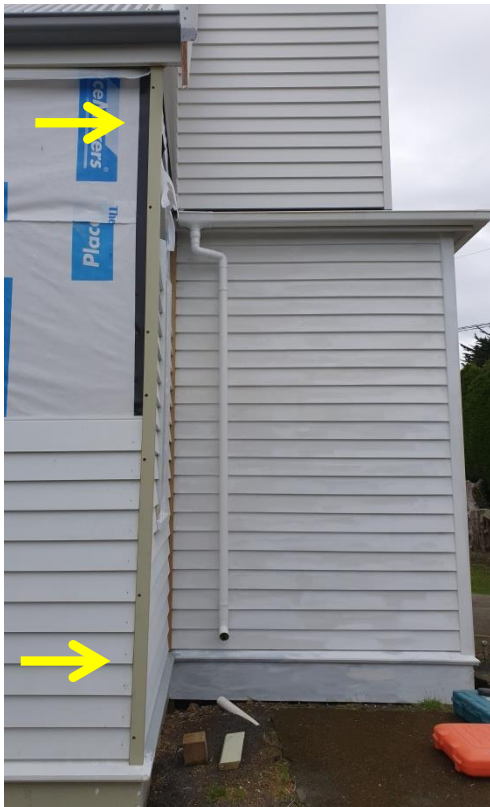
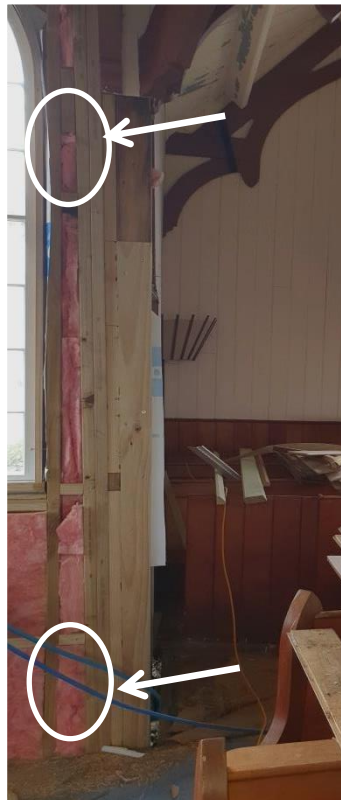
...and talk about crooked walls!! The wonderful eccentricity of the building is being carefully retained:

(Compare stud spacing top and bottom)

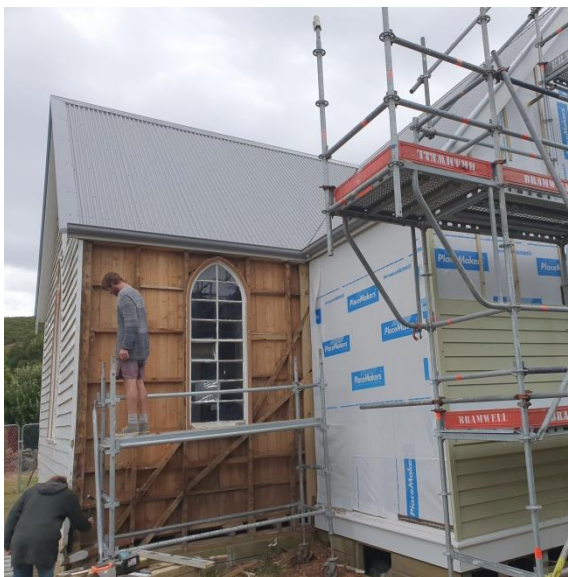
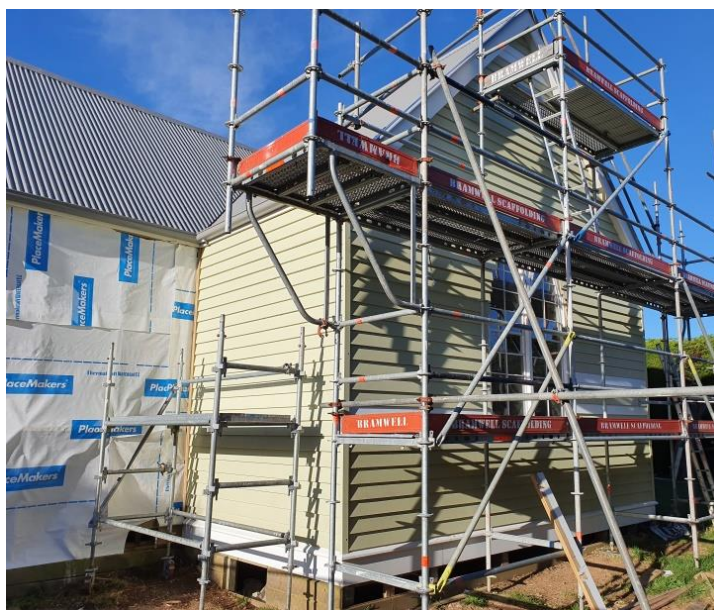
By early May work has continued around the corner to the 'Stage 2' walls. New weather boards have been fitted and are looking good – BUT NOTE that all these weatherboards are only temporarily fitted. All are individually numbered as they now have to come off for end grain sealing and final fitting.

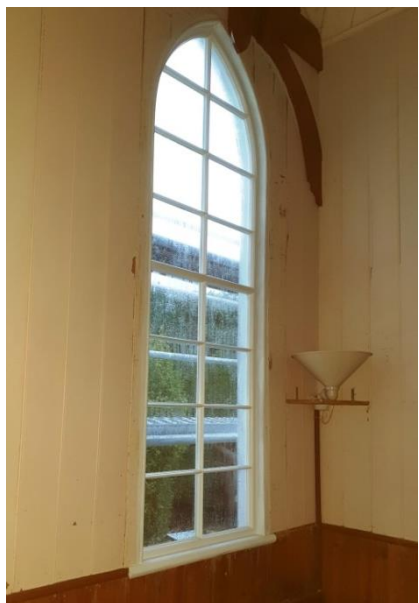
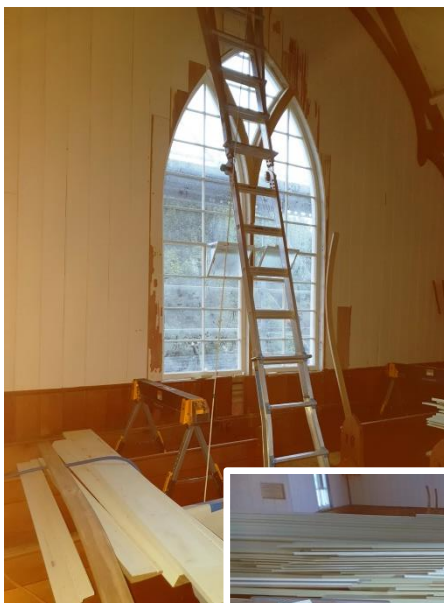
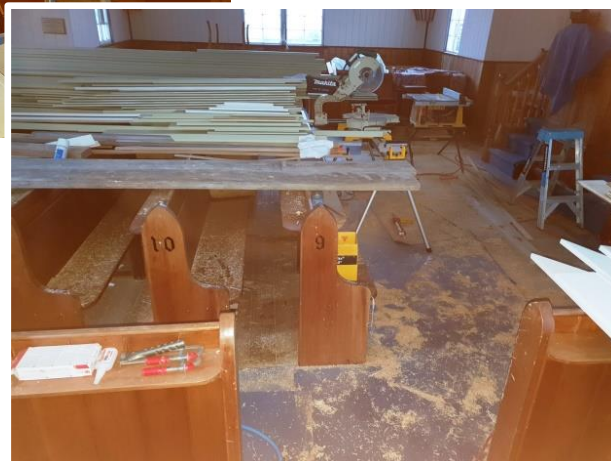
Interior finishing work on the Stage 1 restoration is well underway – with the church interior looking like a joinery workshop! Replacement of the corner light fittings with new uprights, plus spotlights 'hidden' in the rafters is part of the Stage 2 works just commencing.

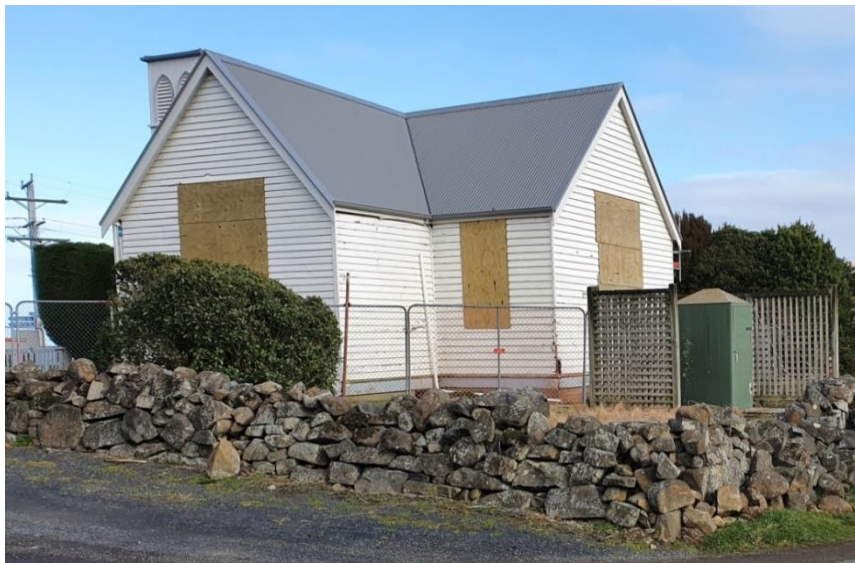
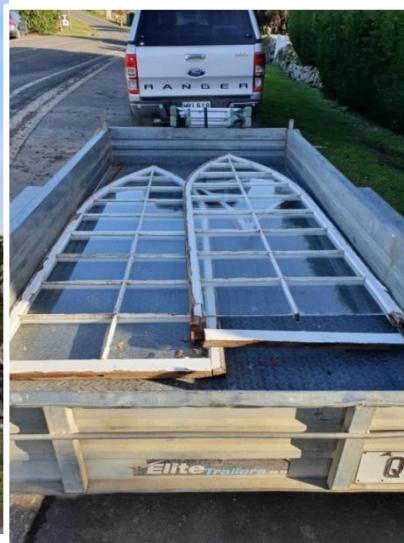
By late August, all four remaining Stage 2 windows have been removed for restoration and further exterior work on site has paused pending the work required on these. The August Level 4 Covid lockdown has however, delayed restoration of the windows due to the unavailability of key materials.

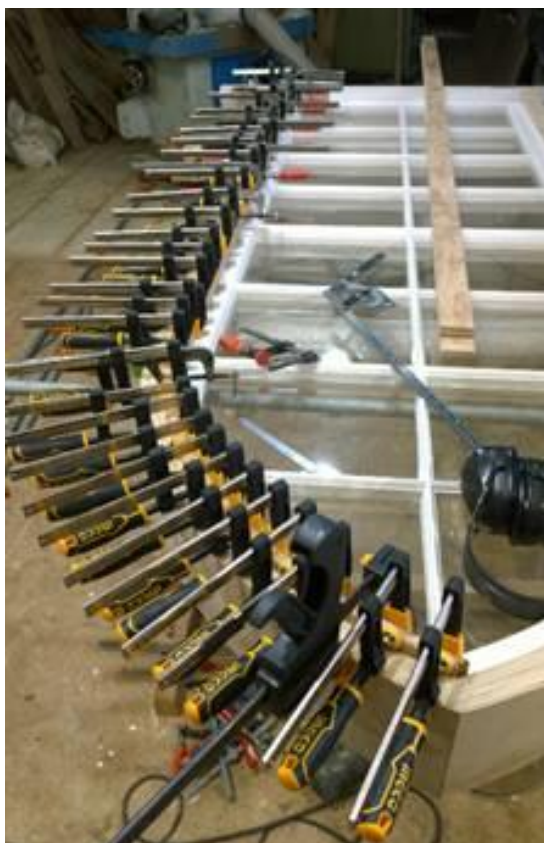
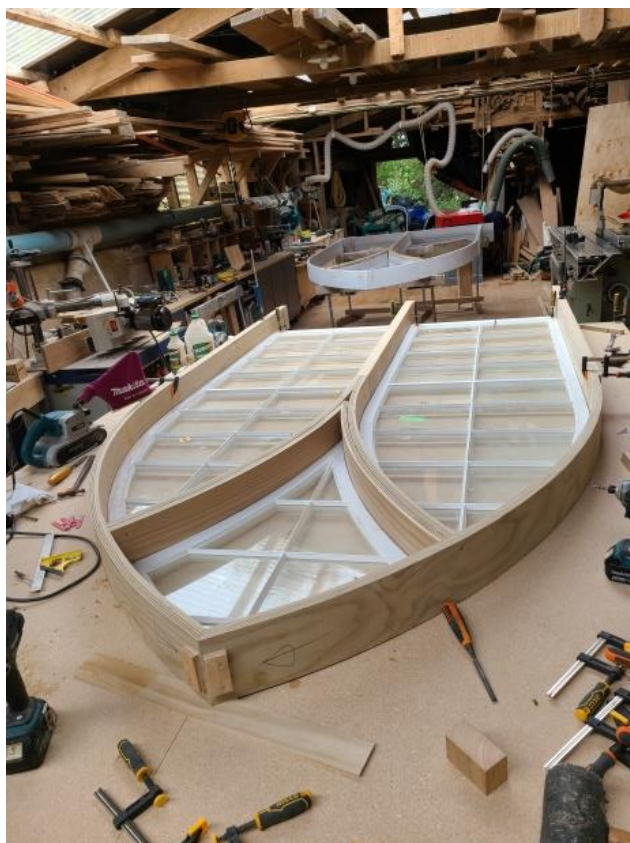
Work is now well advanced on the window restoration – you can never have too many clamps!

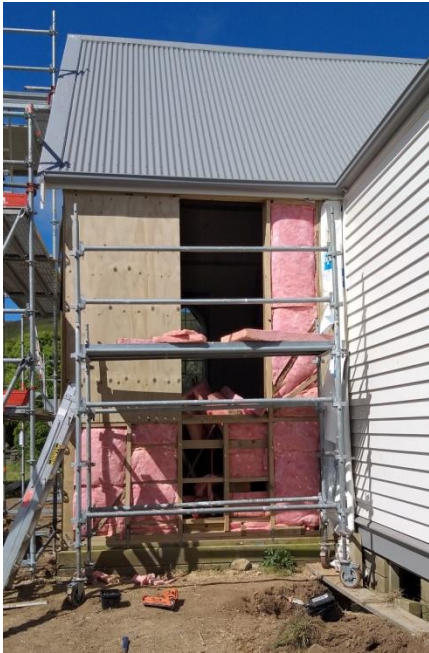
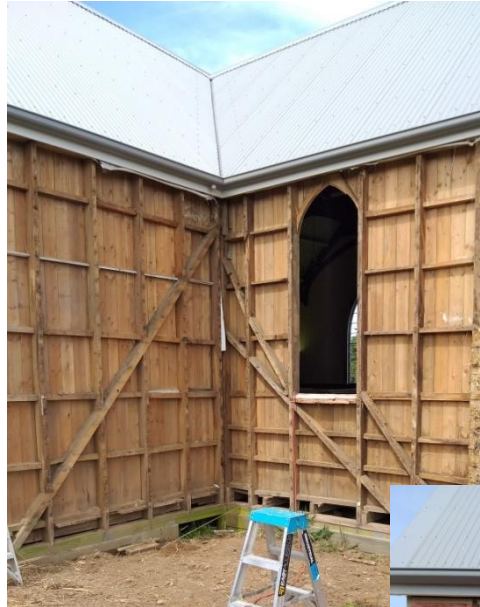
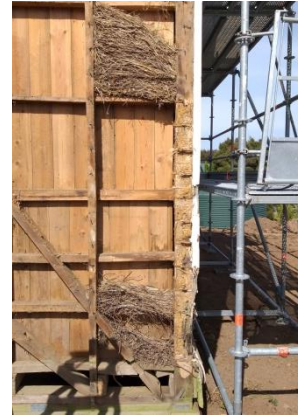
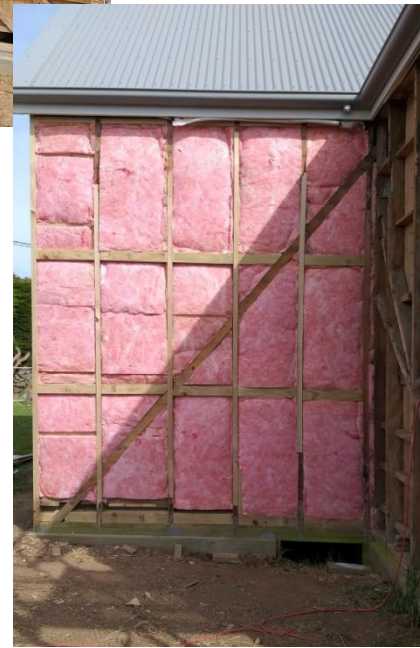
Scaffolding is erected on the end gable and Walter's original construction is revealed!! All studs are cut by the diagonal bracing giving the wall its great flexibility, - noticed when you simply lean on the wall!

“Probably fair to say this has been the worst wall for work required to prepare due to deformation, but not much decay apart from the corner studs. However other areas of decay were getting established and would soon have become very significant.

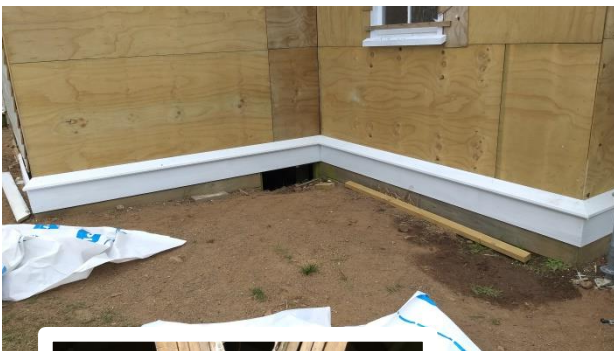
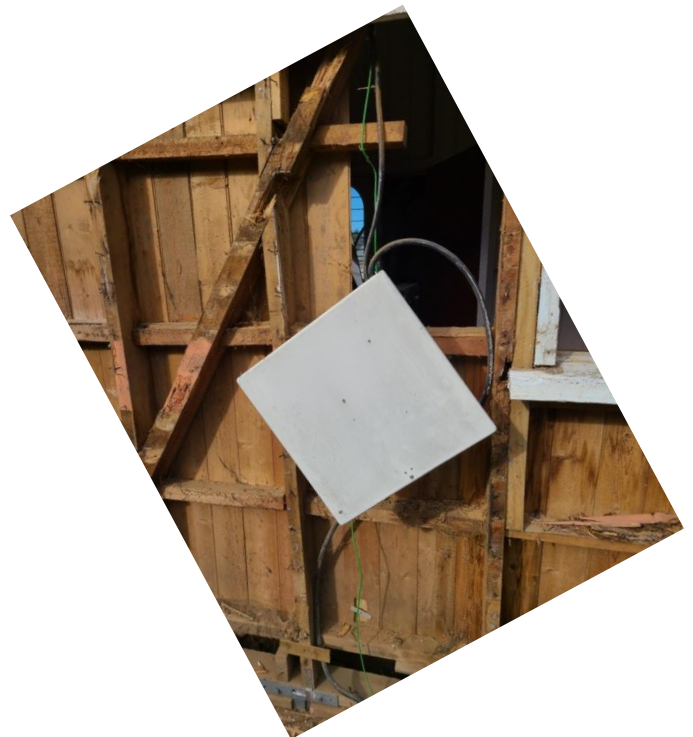
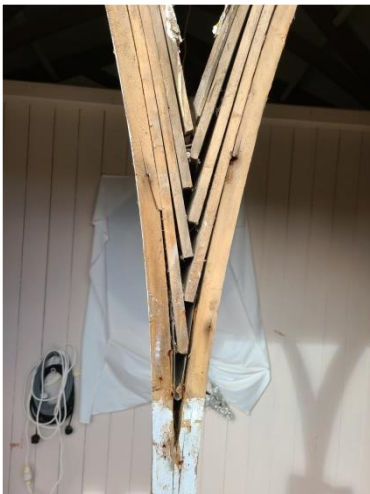
After a damp start to 2022, work once again resumes on the northern walls. The external meter box is readied for relocation inside, in accordance with the Conservation Plan.

Walter Riddell's unique construction of the large NE window is revealed

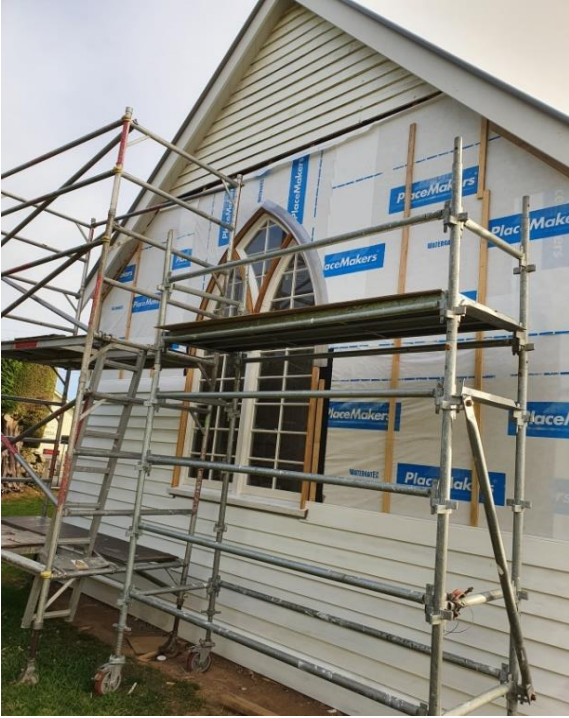
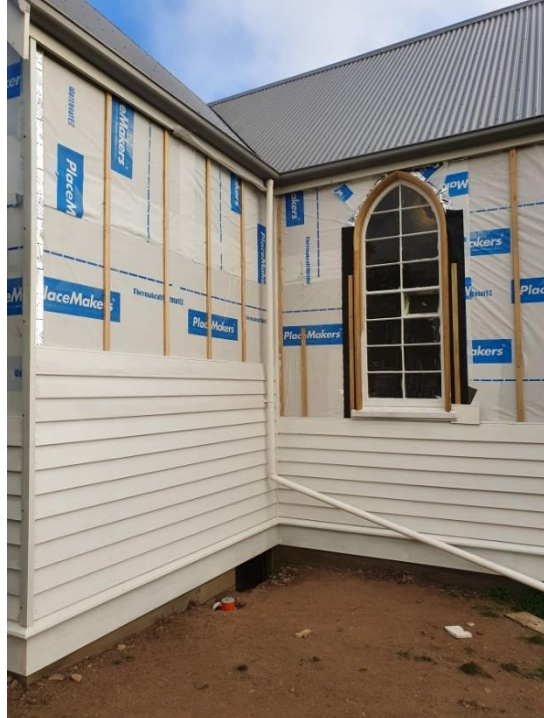
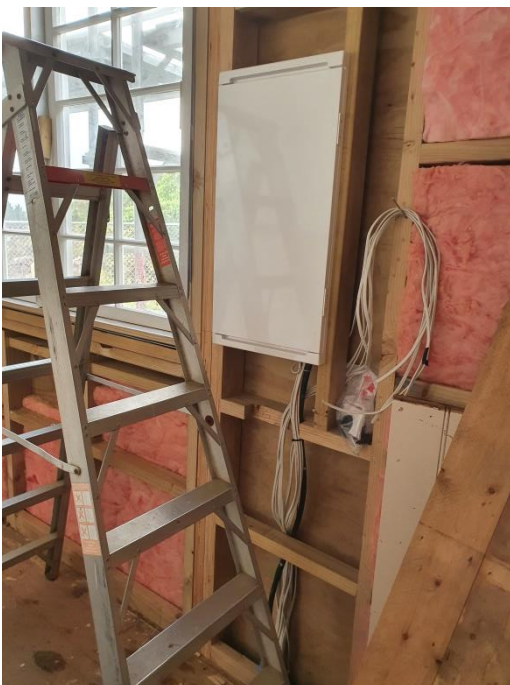
But by the end of March the end is in sight. The new NE large window is now in place, as is the smaller side window.

The new switchboard and meter box is now installed

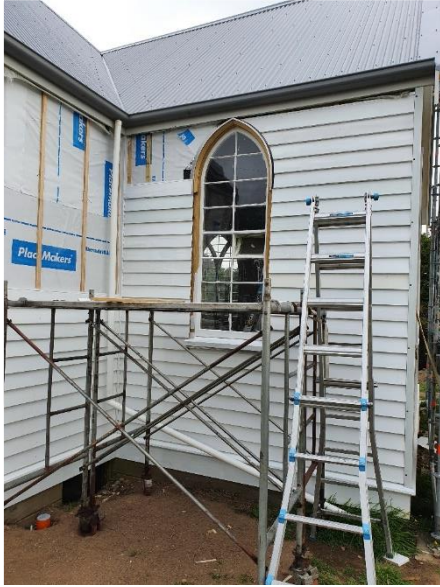
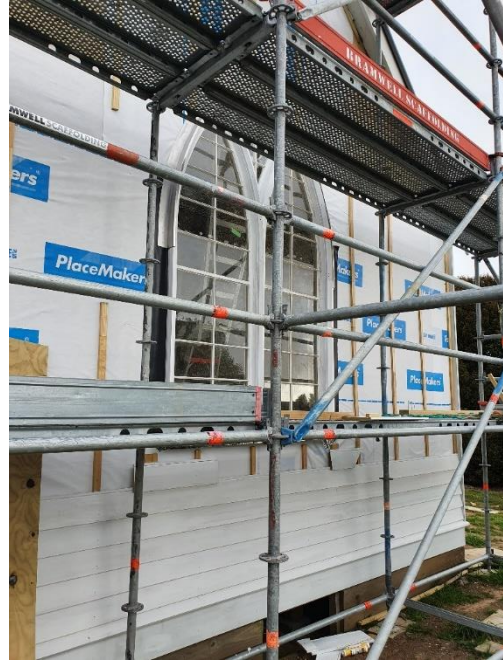
Progress continues, and by Easter, we have the installation of the final large window on the NW gable wall, and more weatherboards in place.

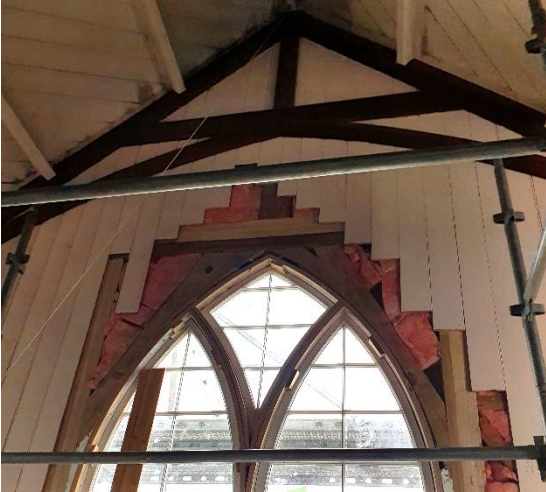
Finishing off inside, around all the new windows, is time consuming.

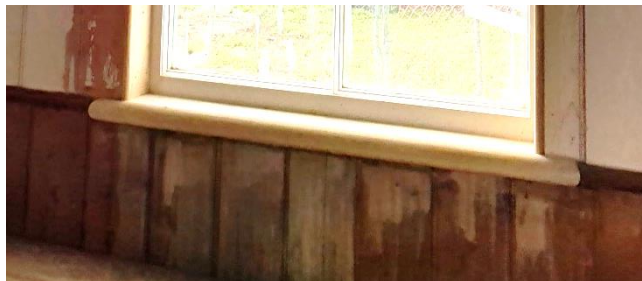
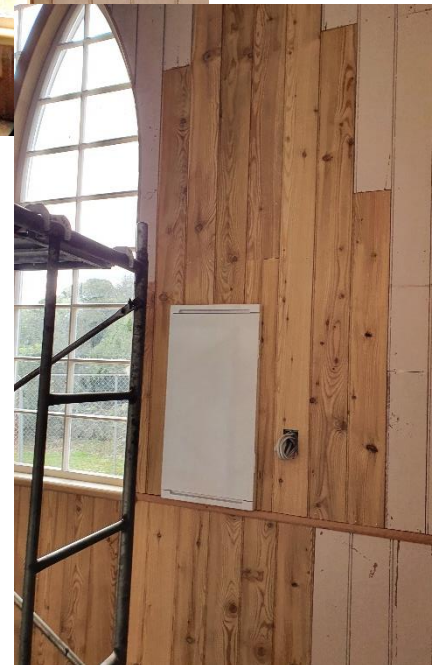
Stuart's attention to detail is displayed everywhere, right down to bending the timber for the window lining (left), machining new panelling (right), and new windowsills (below).
