Pukehiki Community Church 1868

The Restoration Story – A Photographic Record

PUKEHIKI COMMUNITY CHURCH – THE RESTORATION STORY (To November 2023)

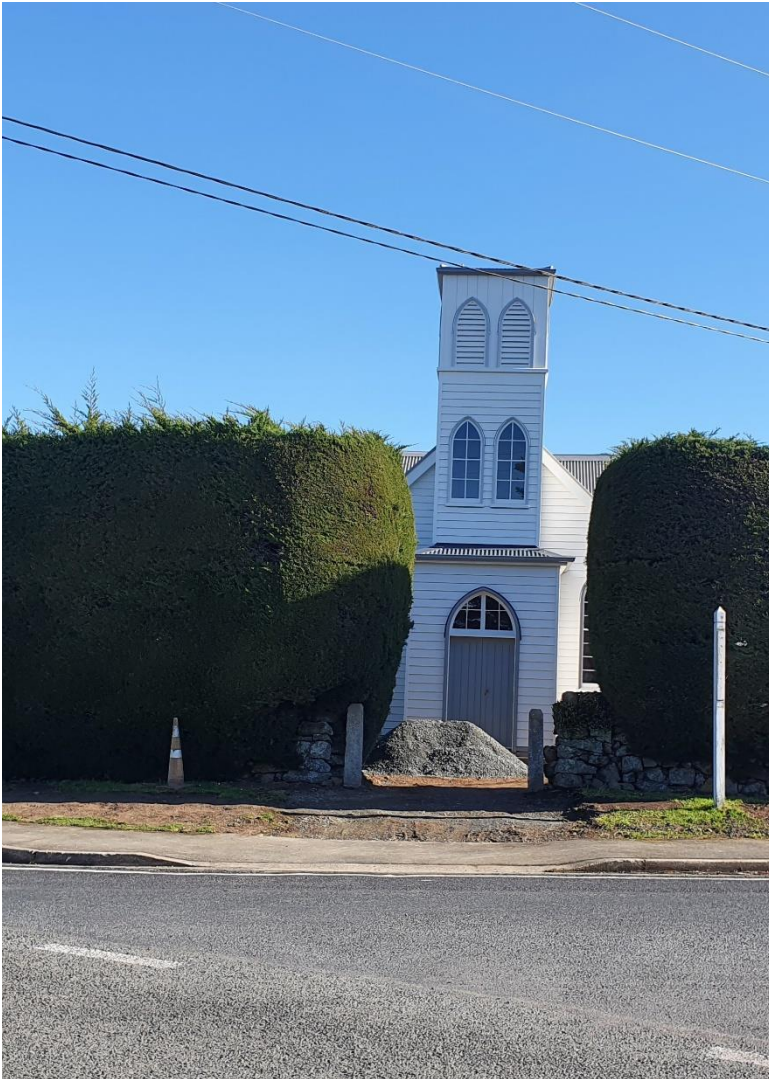
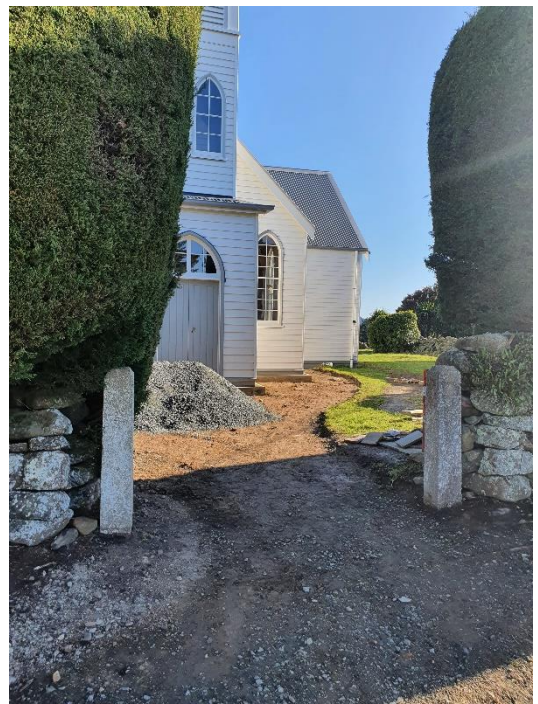
With the approach of Spring, earthworks get underway to spread topsoil around the church, uplift the existing asphalt, regrade the areas to be repaved, and excavate around the front of the church for the new channel detail.

Getting ready for the new paving

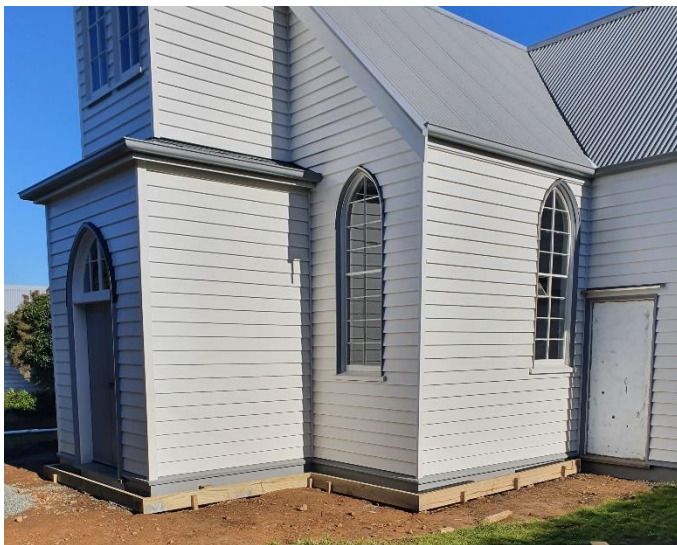
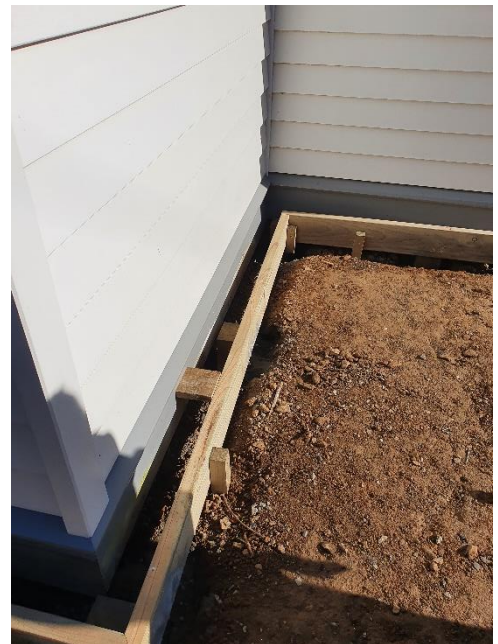
Preparing for the new strip drain around the front of the church

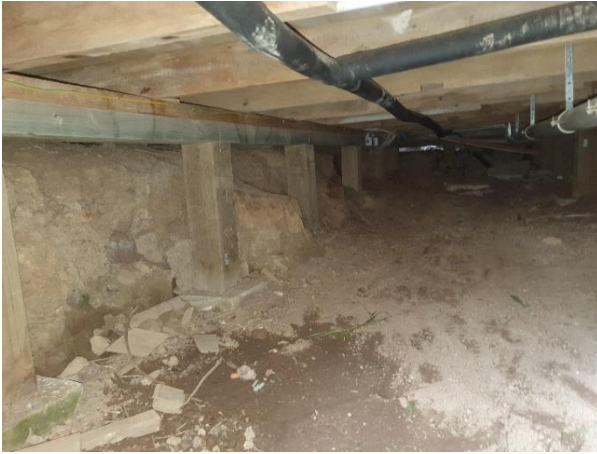
Further excavation under the church was undertaken to accommodate the new heat pump unit and associated large ducting.

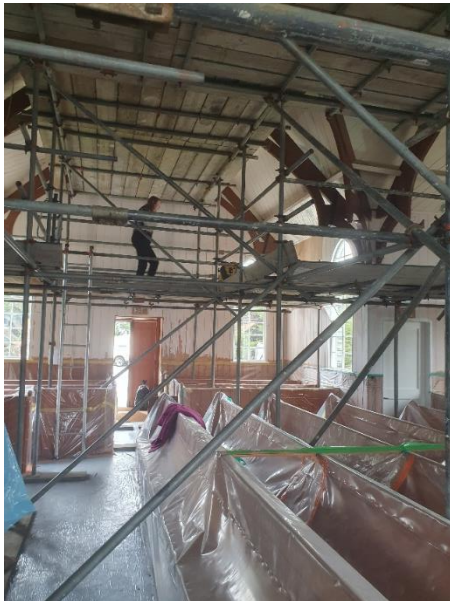
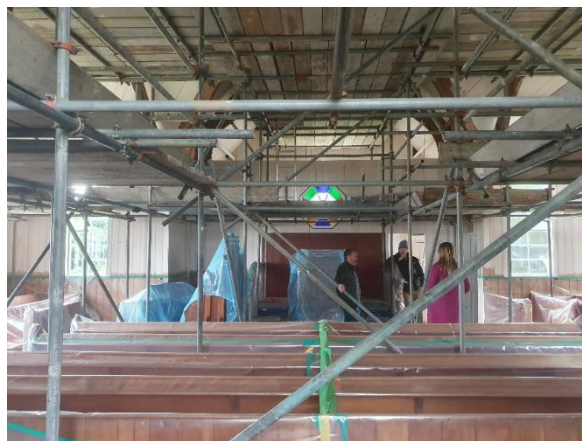
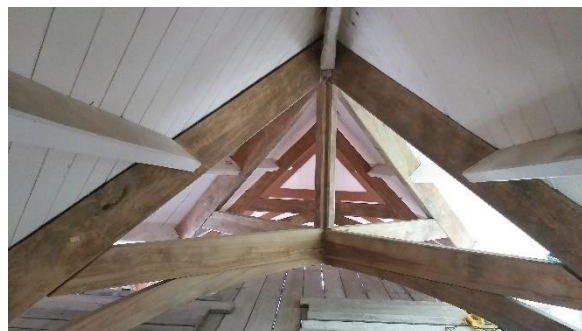
The church is now full of scaffolding and Sims & Blue have a team of painters hard at work.

Can't get higher than this!

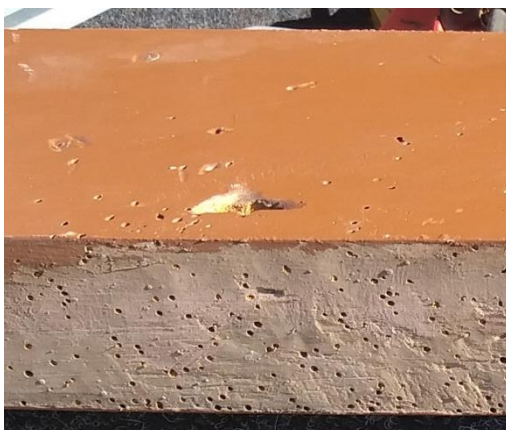
One rafter is seriously riddled with borer and has to be replaced

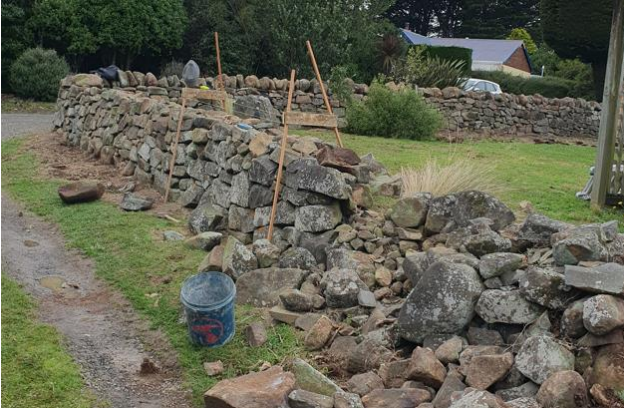
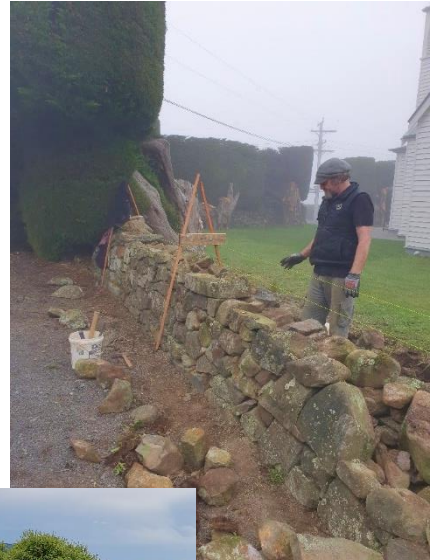
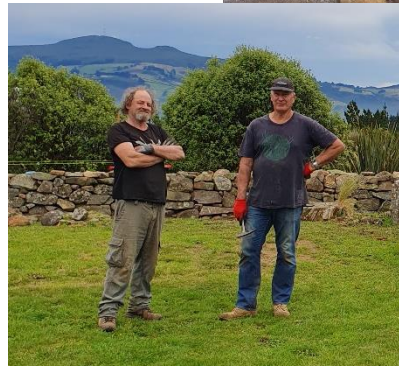
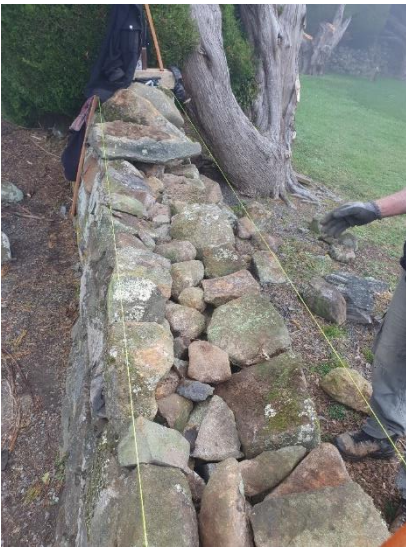
Right on target, work gets underway on restoration of the stone 'dykes', originally built by Robert Landreth, who built many of the local peninsula stone walls, including at Larnach Castle. Now stonemasons, Steven Kilroy and Parry Jones, work their magic in the Pukehiki mist to restore the Pukehiki Church stone walls back to their original glory:

Talk about hard workers! Working 7 days / week the walls are soon complete and look wonderful.

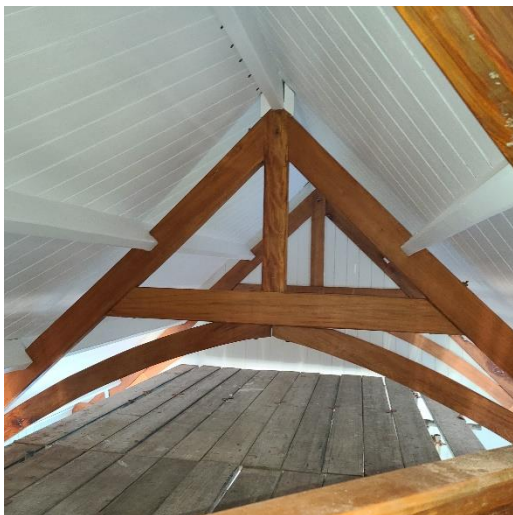
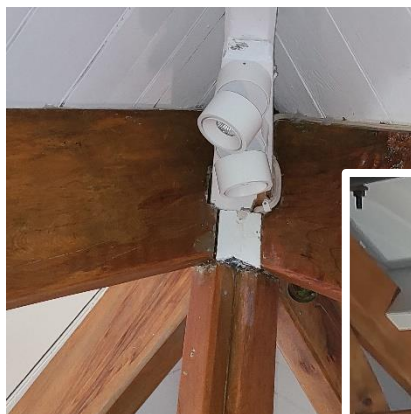
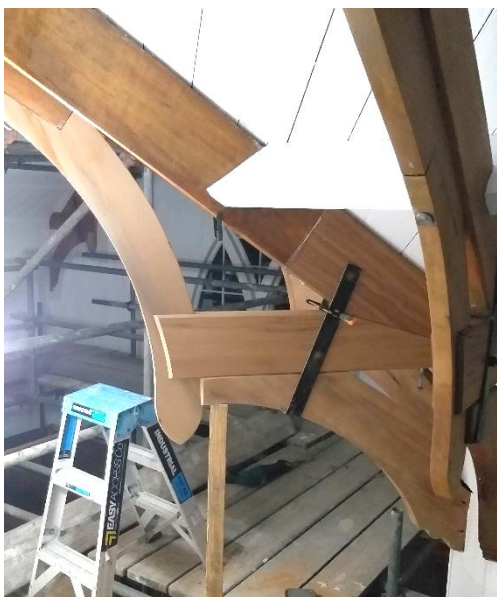
By late June, the interior painting is all but complete, the high level lighting installed, and the two speakers for the sound system installed and tested. The stripped and oiled arch beams look wonderful.

Stuart's arch repairs emulate Walter's original design perfectly

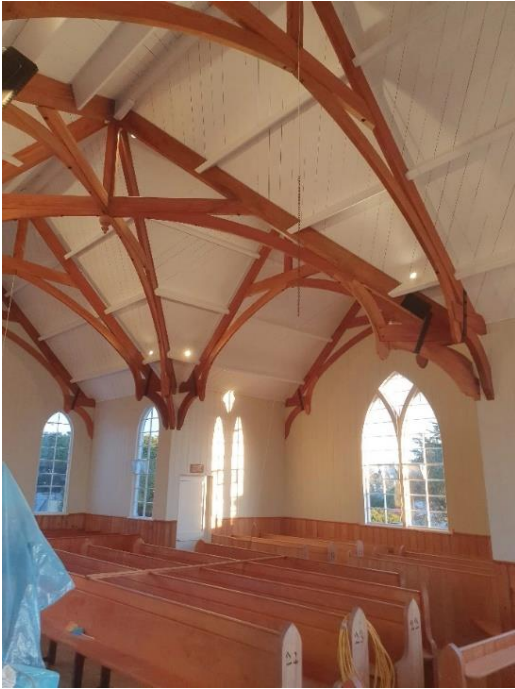
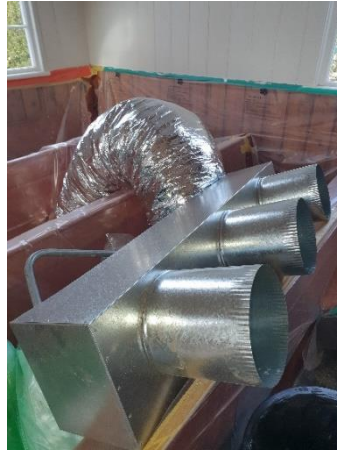
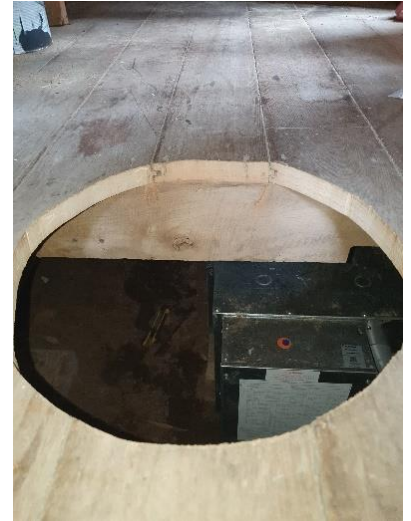
With the scaffolding down, the restored arches look wonderful against the new paintwork. Work now continues on sanding and oiling the pews.

Progress is being made on the new heat pump heating system – the underfloor ducting is substantial! The main heating unit is cunningly located under the hidden floor beneath the pulpit area.

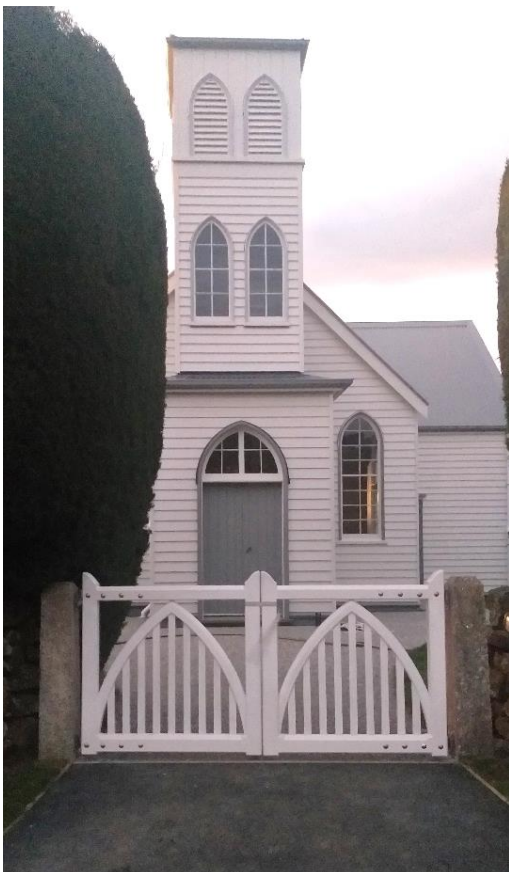
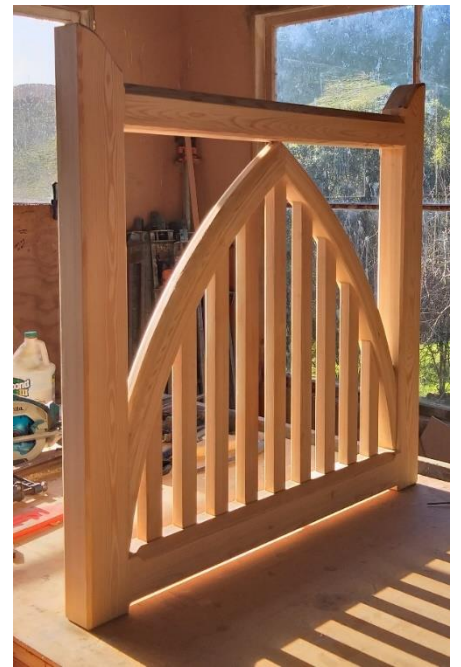
... and Stuart's craftsmanship is ever evident in this sneak preview of the new replica gates made from Siberian Larch.

Nearly there! Time for the finishing touches. A pity to cover Stuart's craftsmanship on the gates in white paint, but necessary to match both the original 1880's gate detail, and the gothic arch shape of the windows.

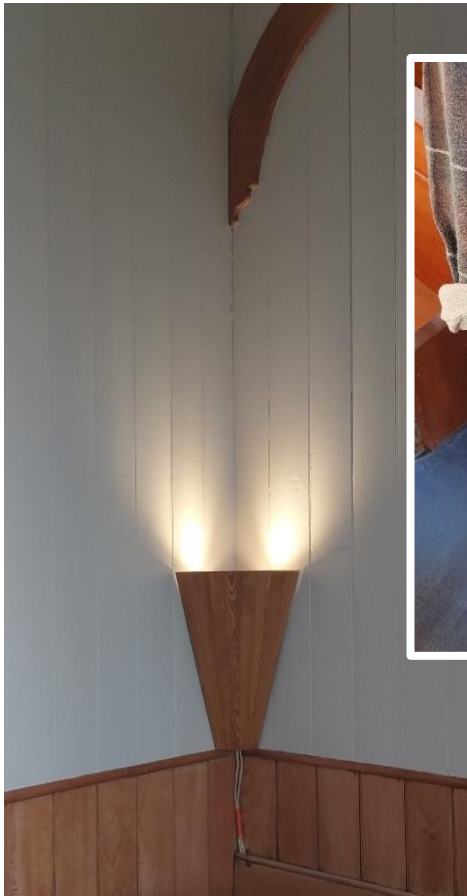
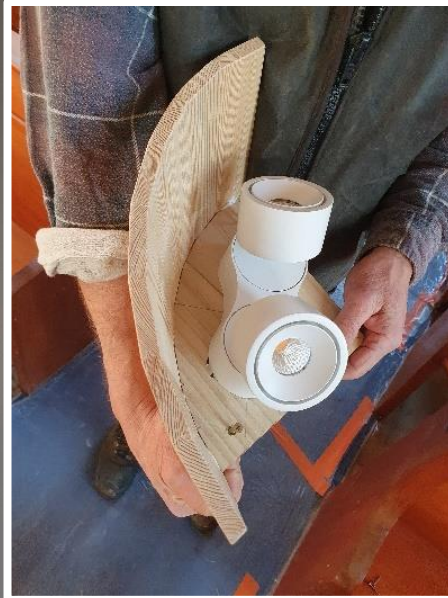
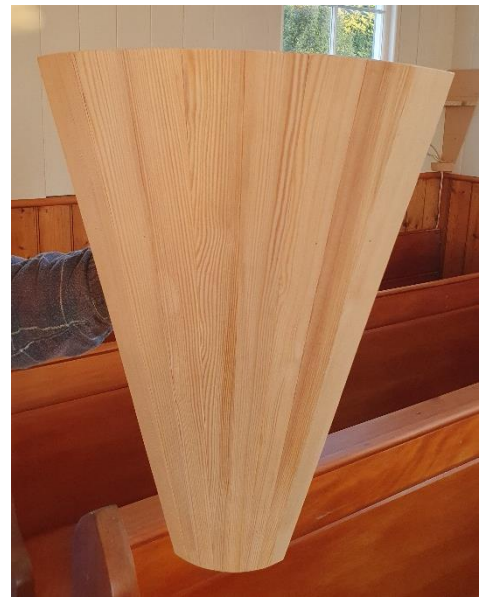
Stuart's craftsmanship continues to the corner lampshades, also from Siberian Larch, requiring a 5-degree angle on the tongue-in-groove jointing to get the required circular shape. They are then stained to match the wainscoting timber below.

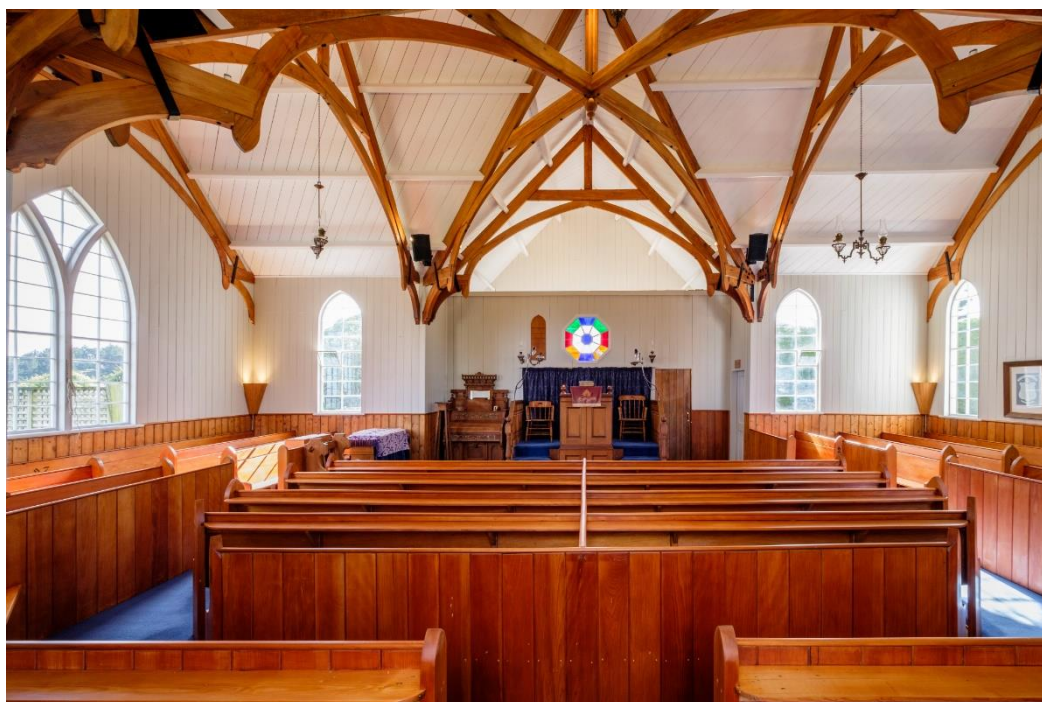
Inside, the stripping of the arches back to natural timber, offset by the freshly painted walls and ceiling, has made an amazing difference; and Peter and his team’s restoration of the pews and wainscoting is nothing short of superb.
