BACKGROUND (Pre-2020)

2020 – STAGE 1 RESTORATION

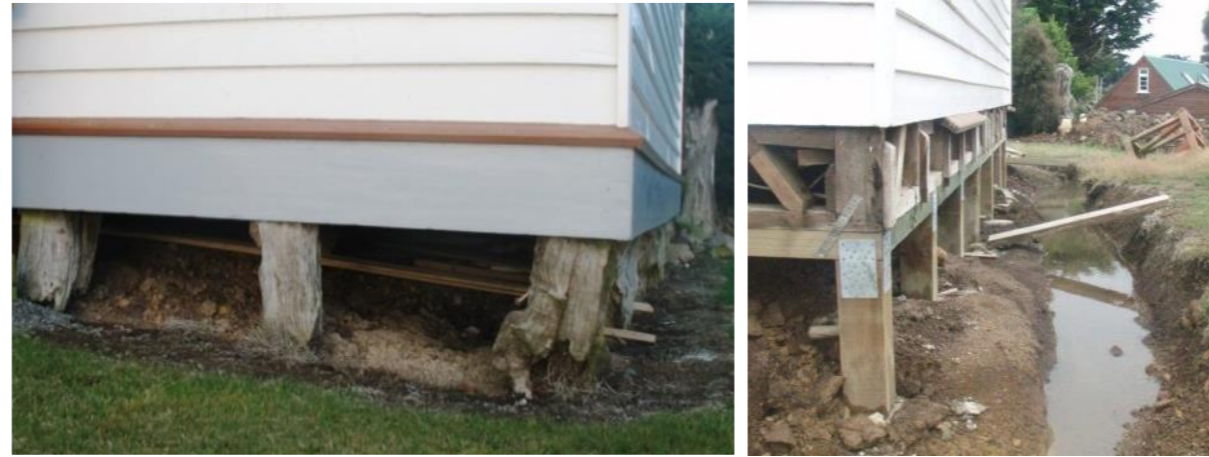
2008/09 Repiling works are completed, and drainage works undertaken

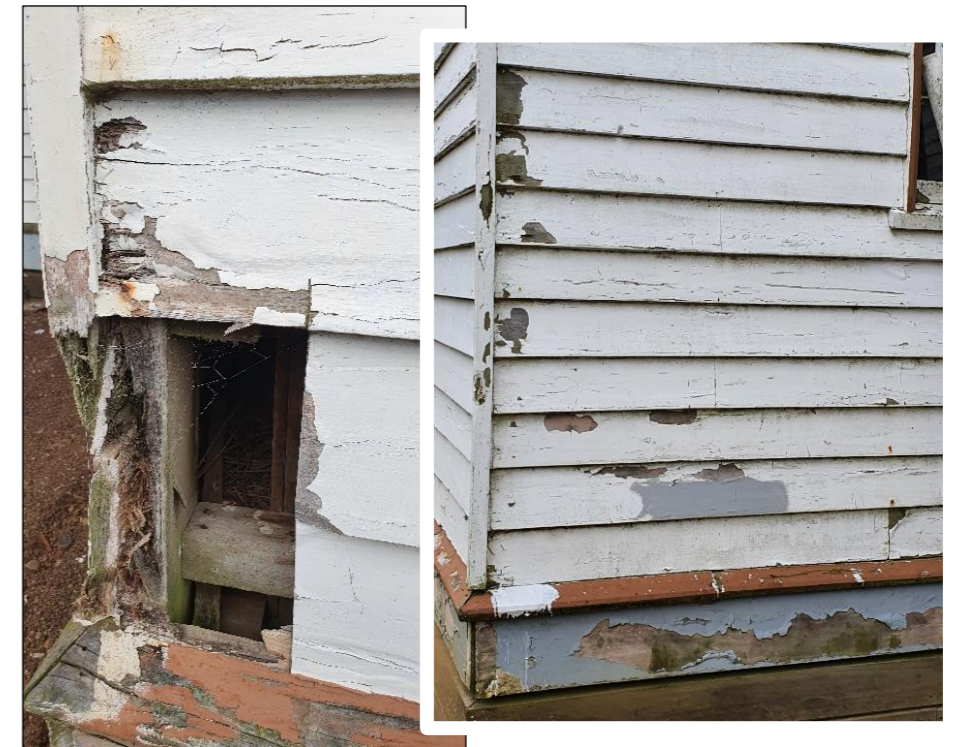
After a 5-year break to repay loans for the repiling and drainage works, local joiner Stuart Robertson was asked to repair a couple of weatherboards prior to repainting the church.

Alas everything was found to be in an overwhelming state of decay due to water ingress over a long period of time.

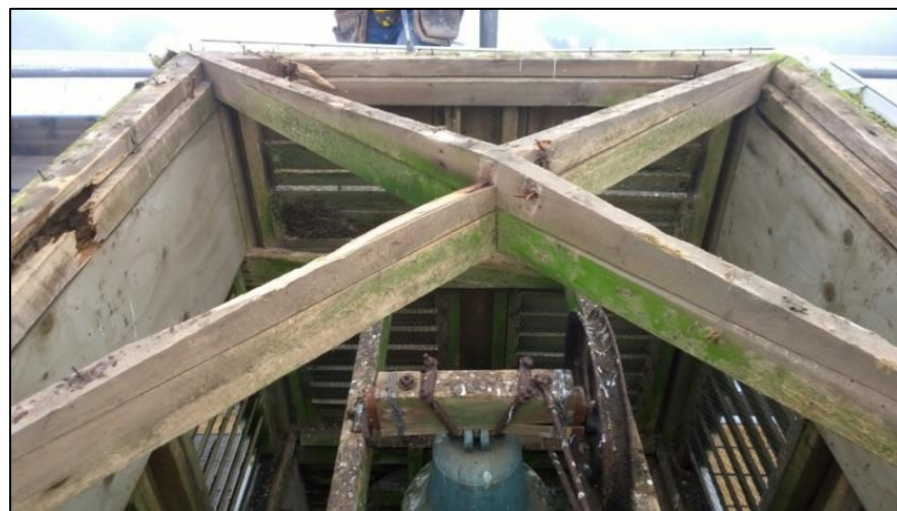
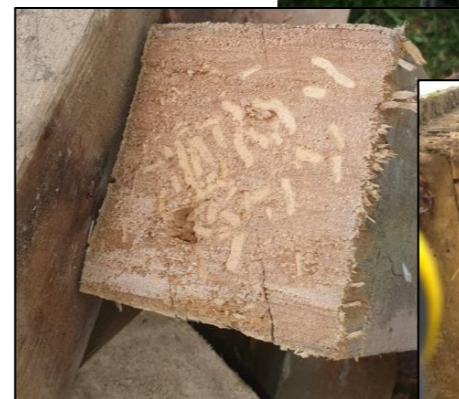
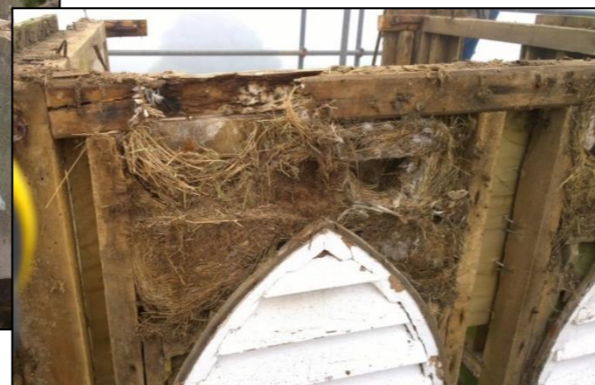
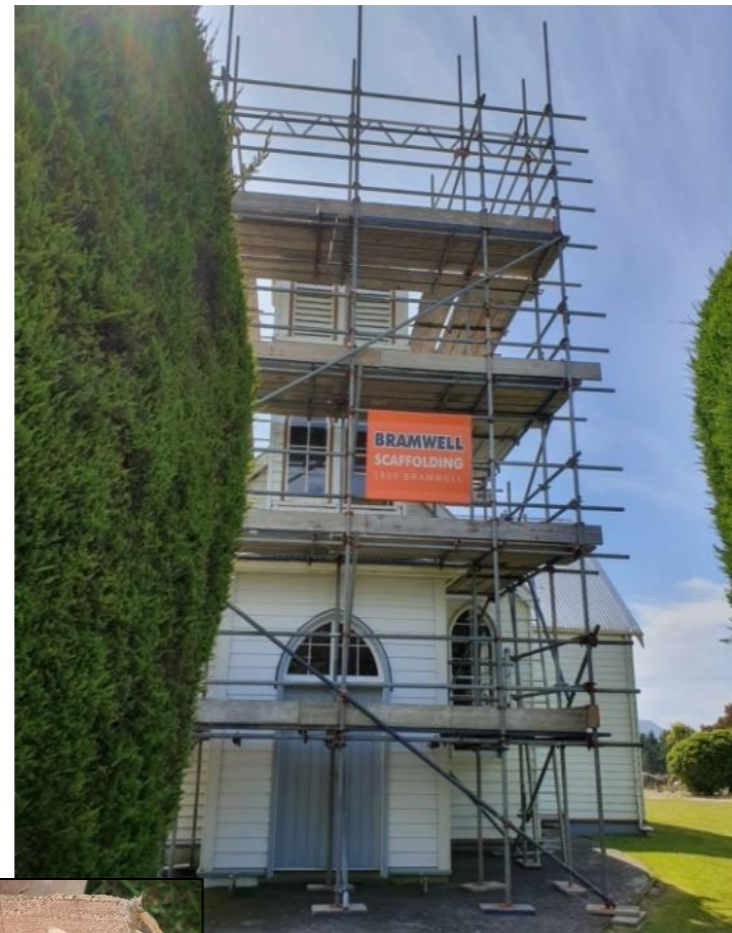
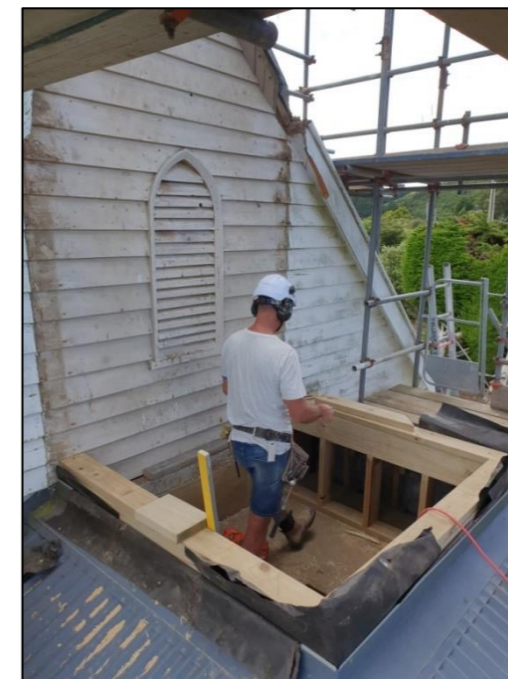
January / February 2020: Stuart Robertson, with Graeme Carr and Tom Leckie, get stuck in! With scaffolding erected, the Bell Tower could be inspected. Again, deterioration and rotting timbers were found at every turn. The main support posts of the tower were badly riddled with borer and the windows and louvres badly decayed. The tower needed to be rebuilt.

Note the revelation of the original 1868 church frontage (untouched since then), as it was before the Bell Tower was added in 1884.

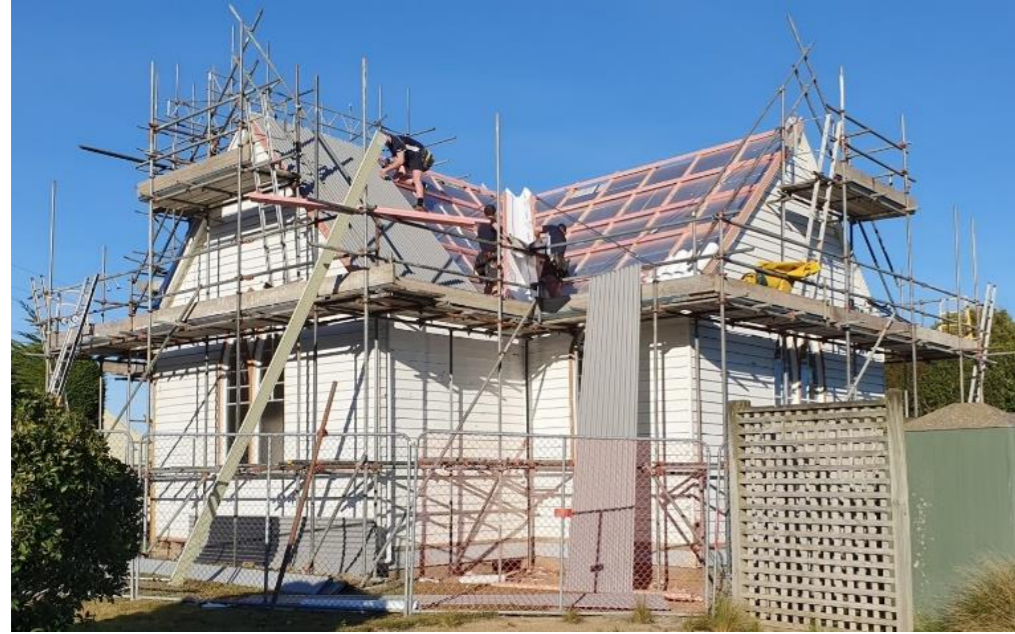
June 2020: After a nearly 2-month Covid-19 break, work finally resumes on site, with a start on the roof replacement .

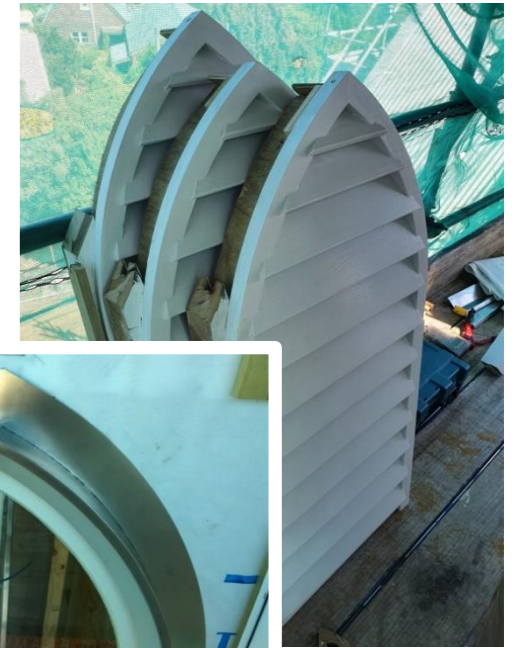
October 2020: After 3-months's restoration in Stuart Robertson's workshop at Sandymount, restoration of the eight tower louvres, the two tower windows, the large southern window, and the four smaller Stage 1 windows, was finally complete. Work commenced back on site.

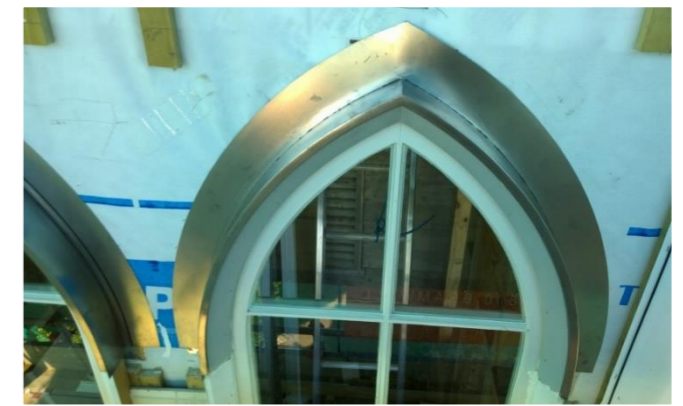
November 2020: Work on the tower is progressing well, though recreating the original construction detailing by Walter Riddell 150 years ago is proving to be a very demanding and intricate process. While these details are being faithfully recreated, attention is being paid to long term weatherproofing, such as the fitting of fabricated stainless steel flashings

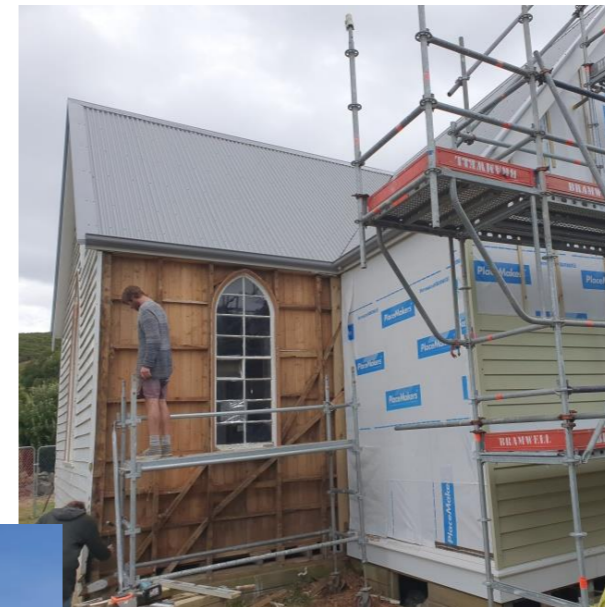
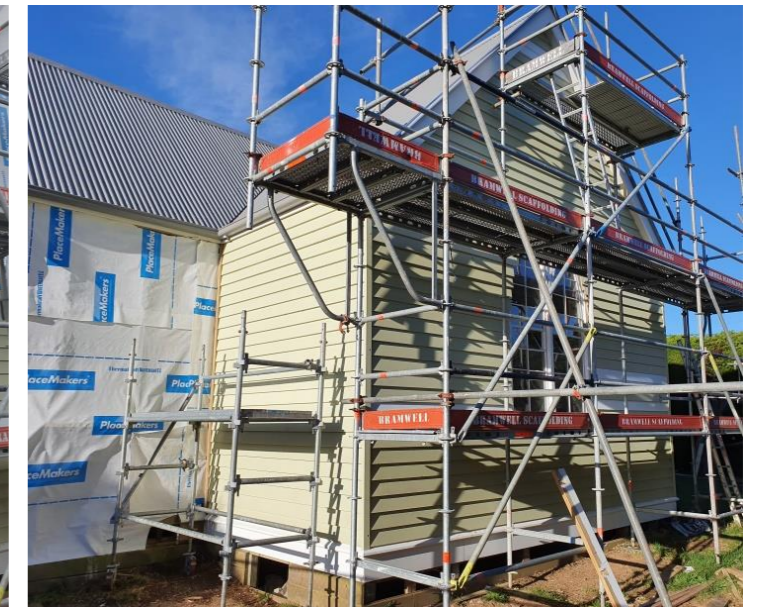
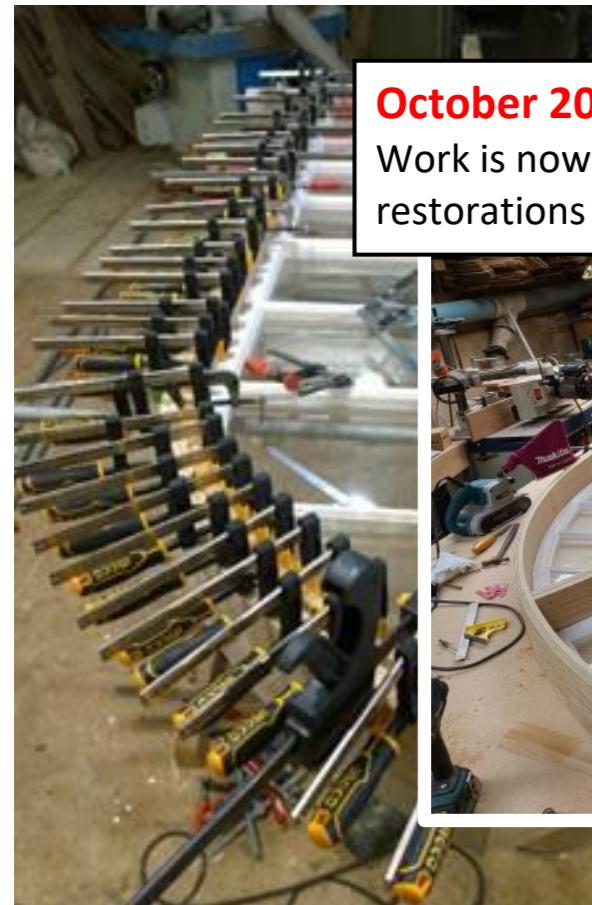
By early May work has continued around the corner to the 'Stage 2' walls. New weather boards have been fitted and are looking good – BUT NOTE that all these weatherboards are only temporarily fitted. All are individually numbered as they now have to come off for end grain sealing and final fitting.

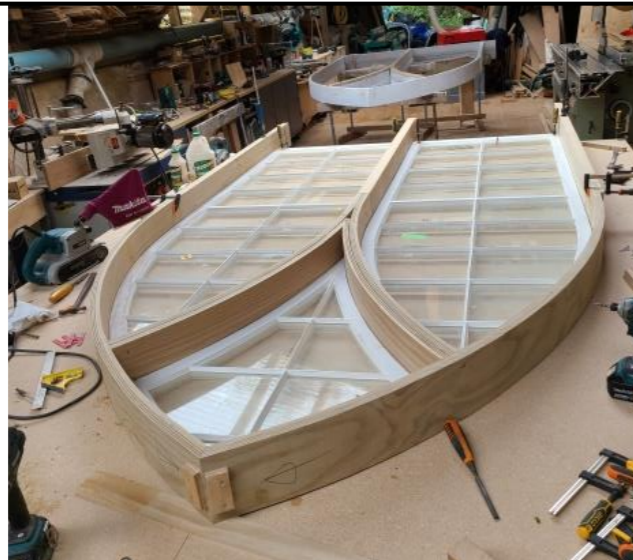
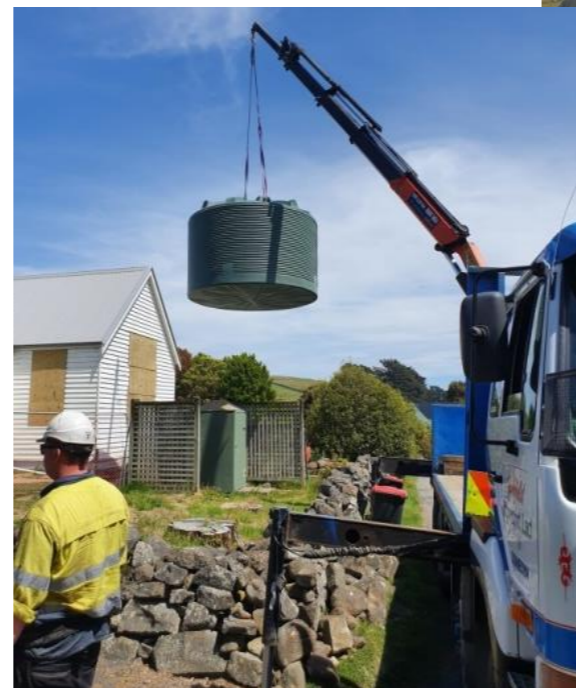
Work is now well advanced on the remaining window restorations – you can never have too many clamps!

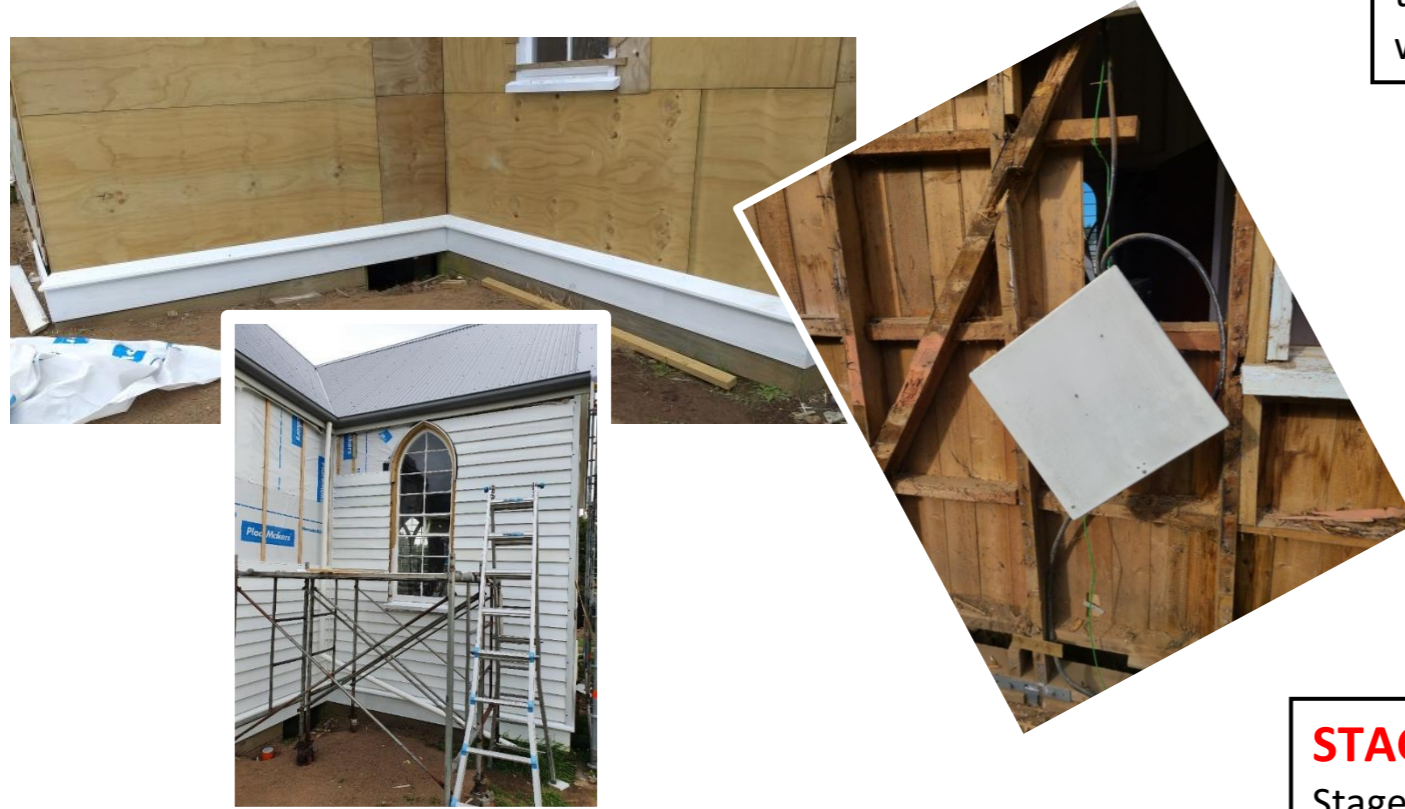
January 2022: After a damp start to 2022, work once again resumes on the northern walls. The external meter box is readied for relocation inside, along with a new switchboard.

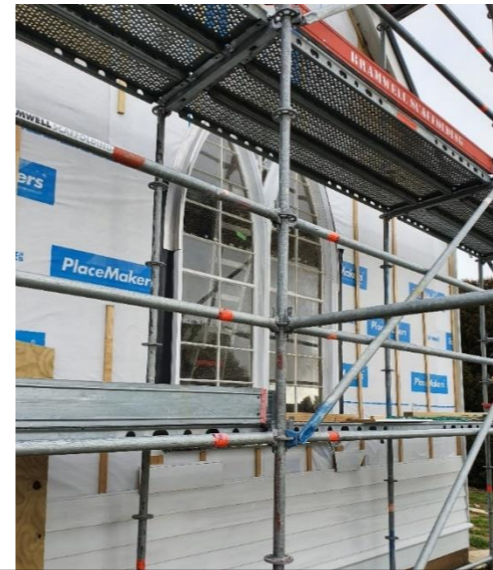
April – July 2022: Progress continues, and by Easter, we have the installation of the final large window on the NW gable wall, and more weatherboards in place.

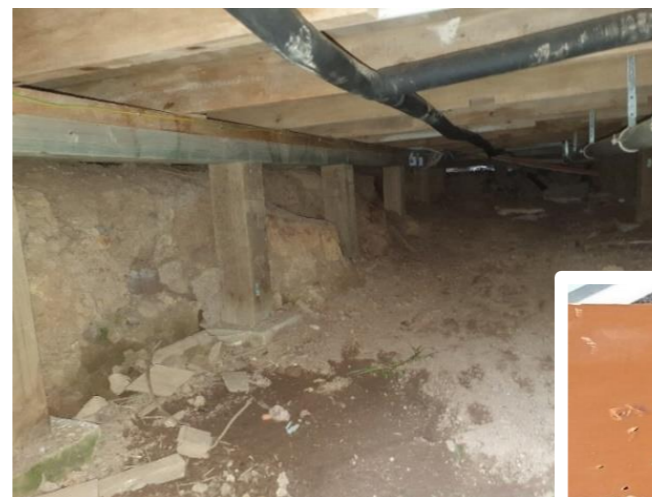
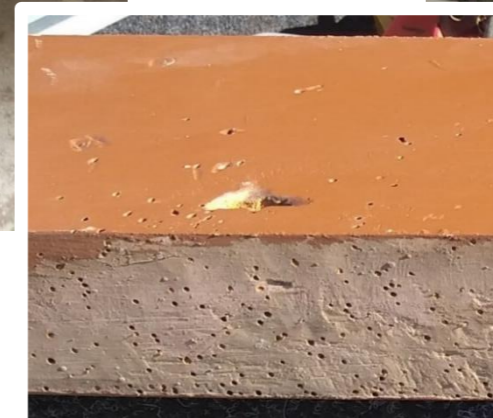
STAGE 3 February – March 2023 After a pause over December/January, the Stage 3 works started in earnest. Further excavation under the church was undertaken to accommodate the new heat pump unit and associated large ducting

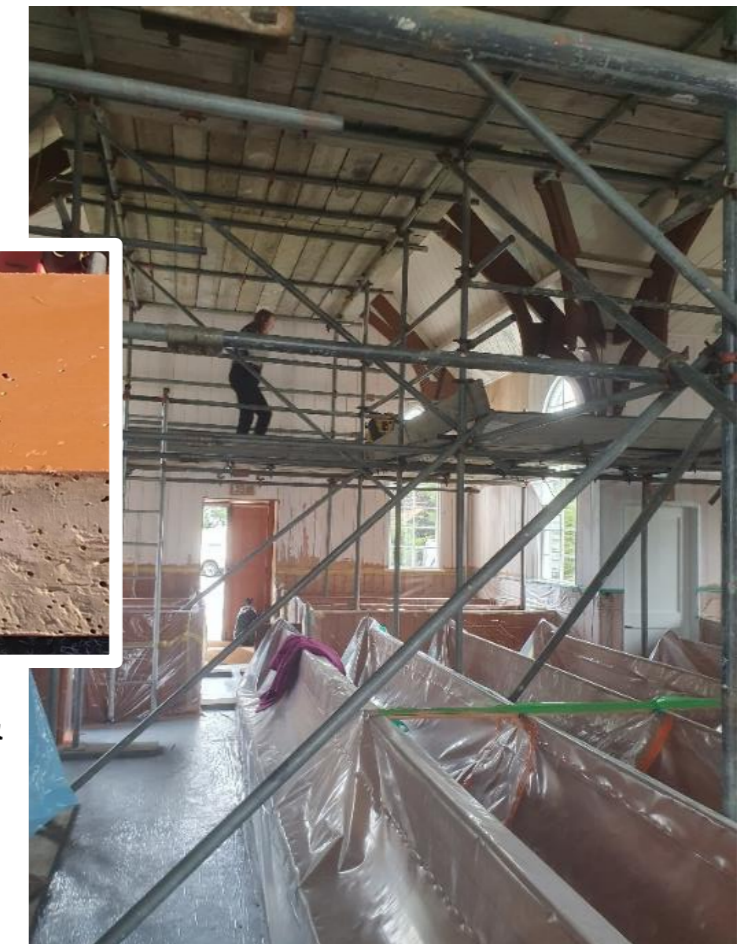
April 2023: The church is full of scaffolding as Sims & Blue's painting team get to work. One arch rafter is seriously riddled with borer and has to be replaced.

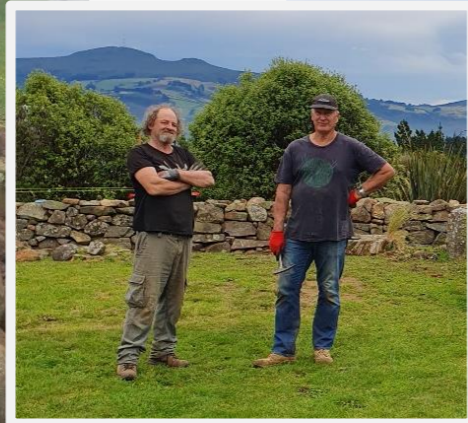
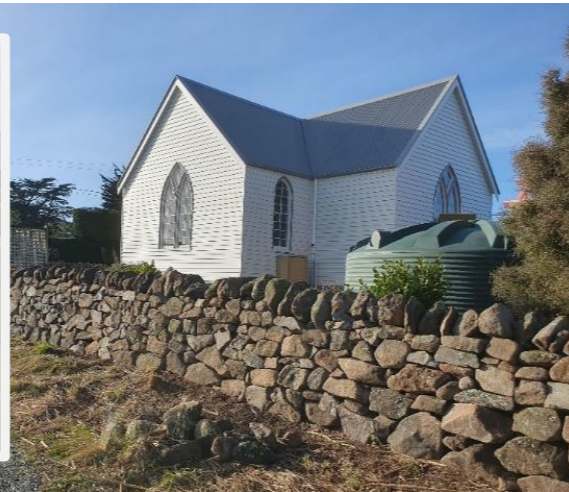
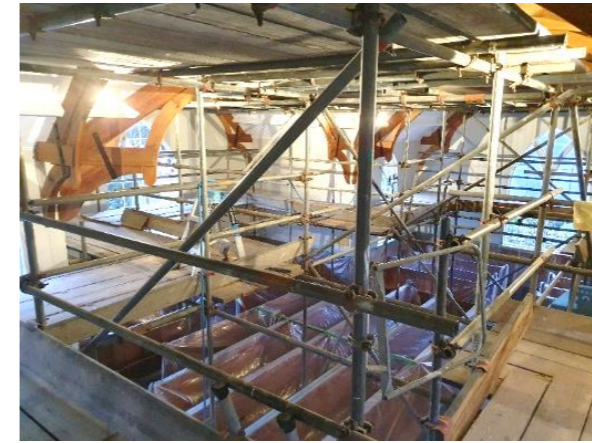
May 2023 Work gets underway on restoration of the stone 'dykes', originally built by Robert Landreth, who built many of the local peninsula stone walls, including at Larnach Castle. Stonemasons, Steven Kilroy and Parry Jones, work their magic in the Pukehiki mist to restore the Pukehiki Church stone walls back to their original glory:

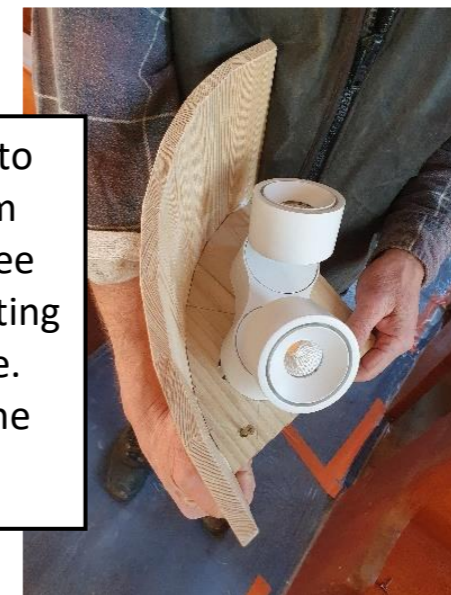
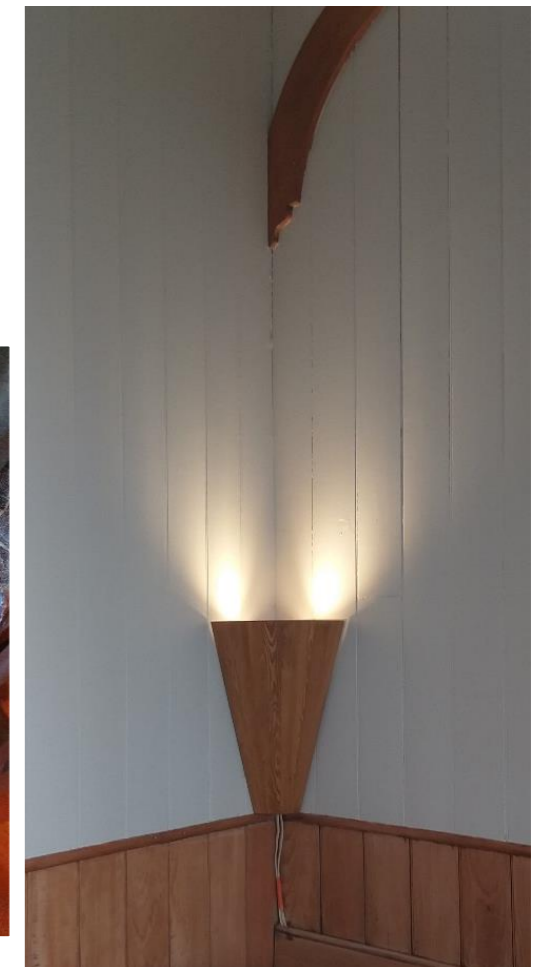
Nearly there! Time for the finishing touches. A pity to cover Stuart's craftsmanship on the gates made from Siberian Larch, in white paint, but necessary to match both the original 1880's gate detail, and the gothic arch shape of the windows.

Stuart's craftsmanship continues to the corner lampshades, also from Siberian Larch, requiring a 5-degree angle on the tongue-in-groove jointing to get the required circular shape. They are then stained to match the wainscoting timber below.
